BIA 2 – Rural Safety and Regional Access Project  
BIA 2 Site Photos – Rural Section

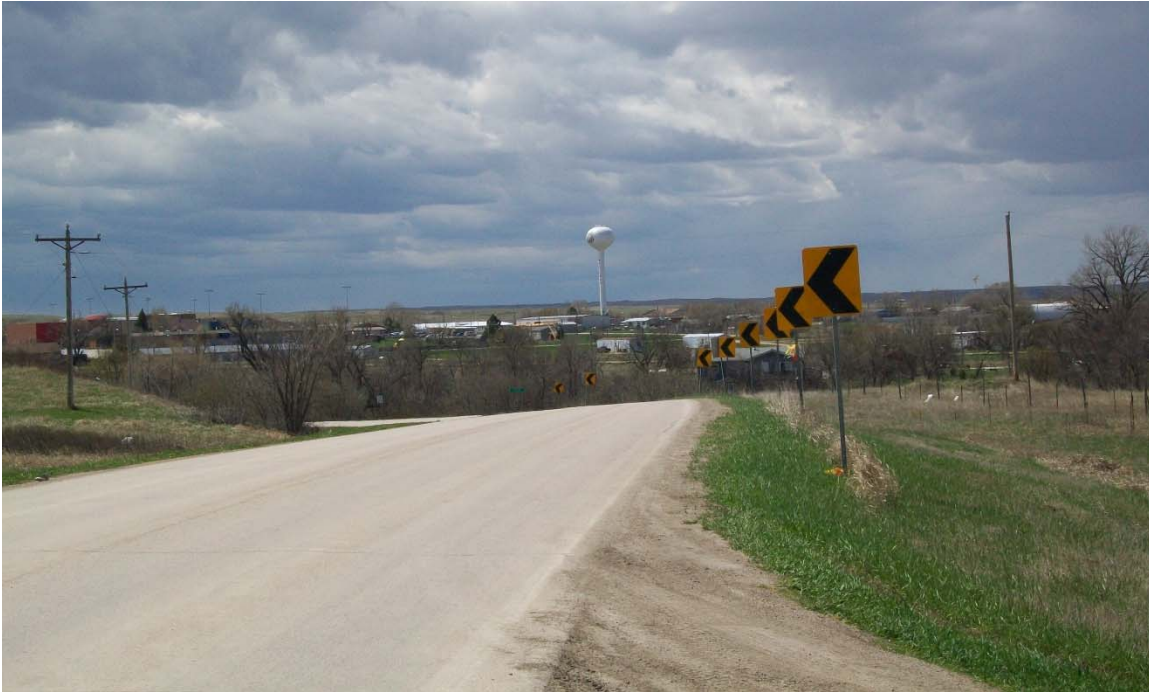
BIA 2 – looking west at Kyle

The following photos show a severe compound horizontal curve combined with vertical curve on the east side of Kyle. The project would straighten the horizontal curves and flatten the vertical curve. The photos also show the lack of shoulders and steep side slopes. Many crashes are concentrated in this area.

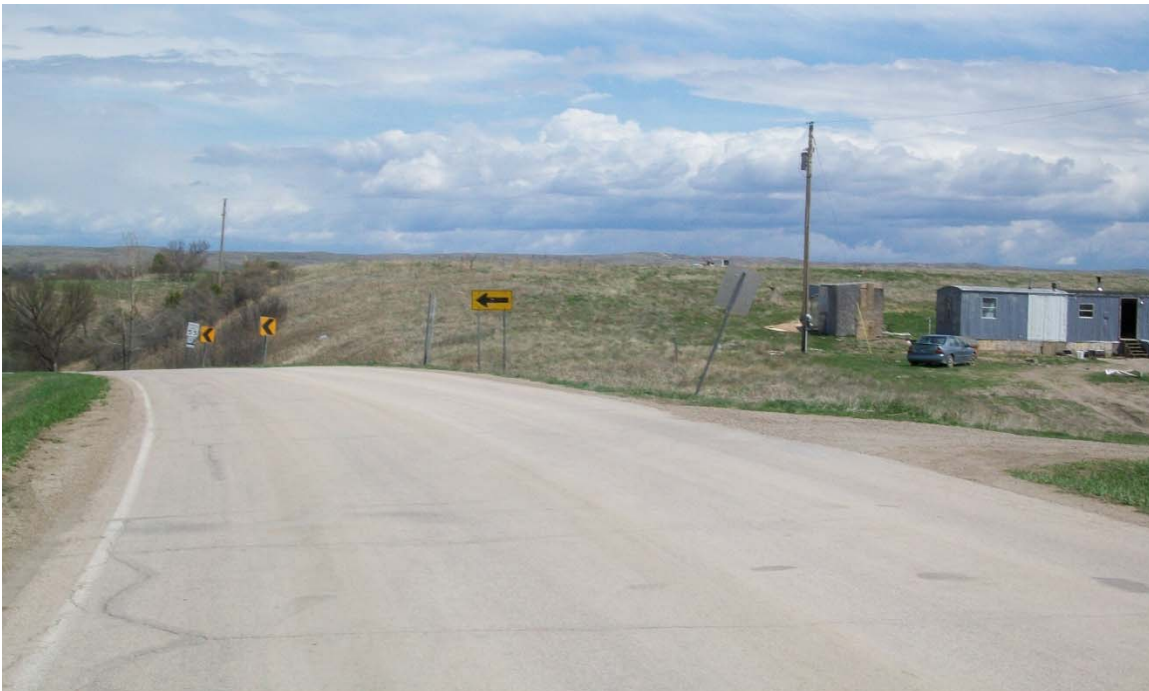
BIA 2 – looking east at compound horizontal curves and vertical curve

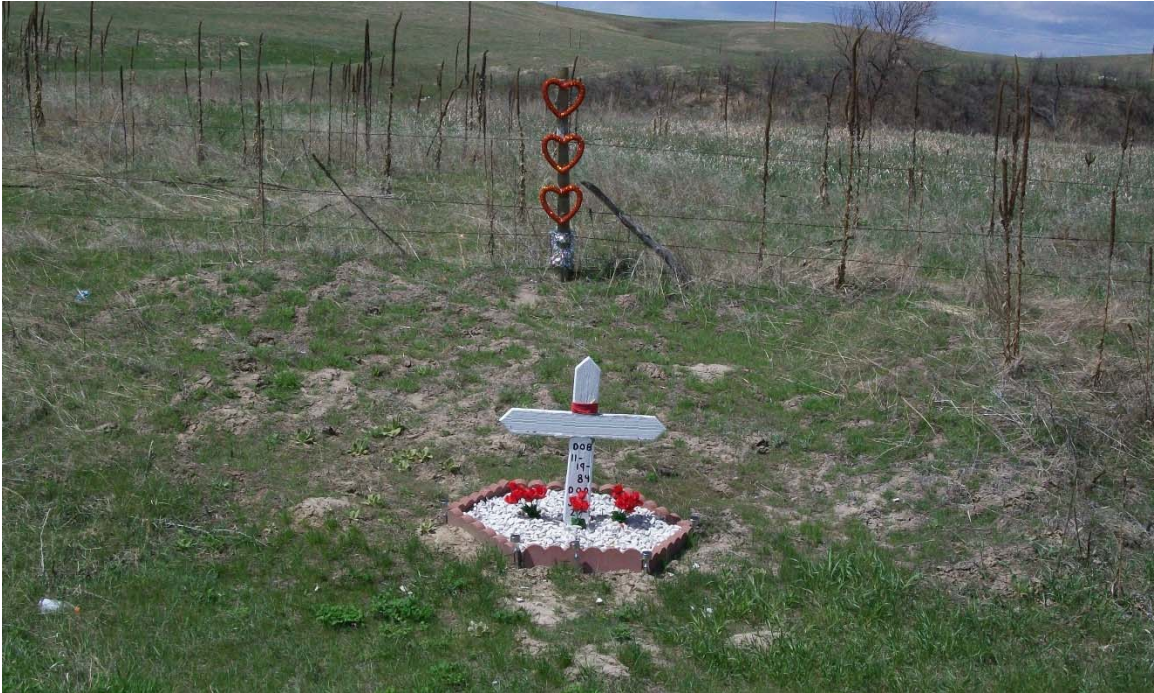
Many fatal crashes are marked by memorials along the project route

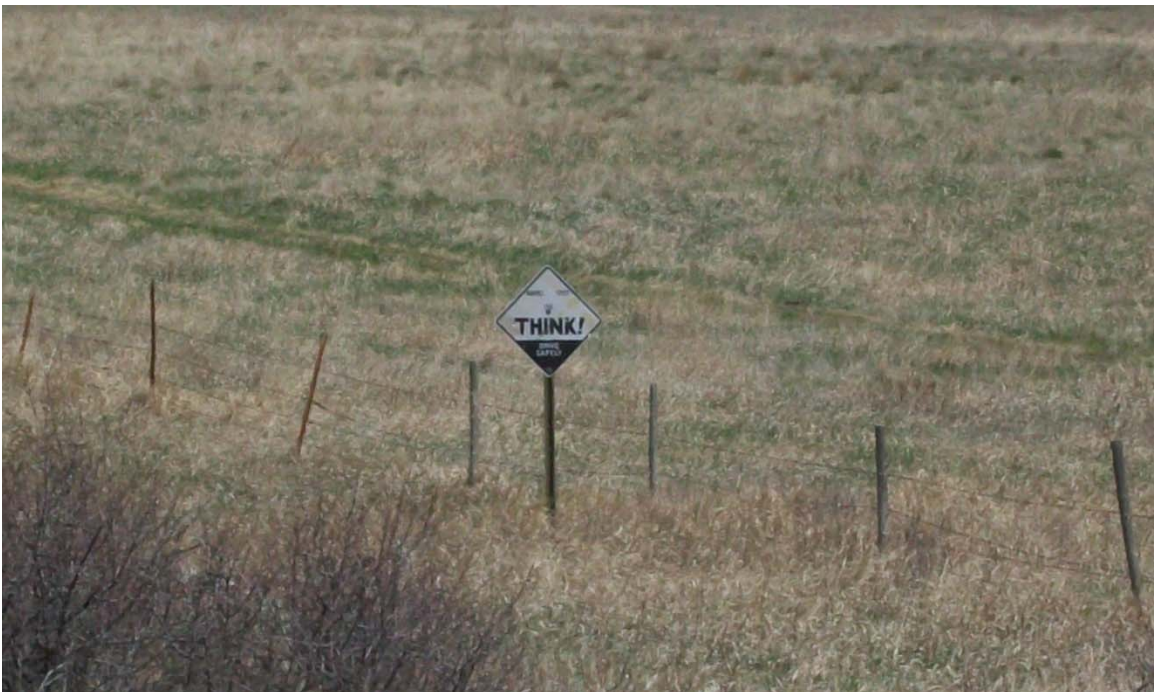
South Dakota marks fatalities with “THINK” signs. This sign is faded and located near Kyle, SD along the project route.

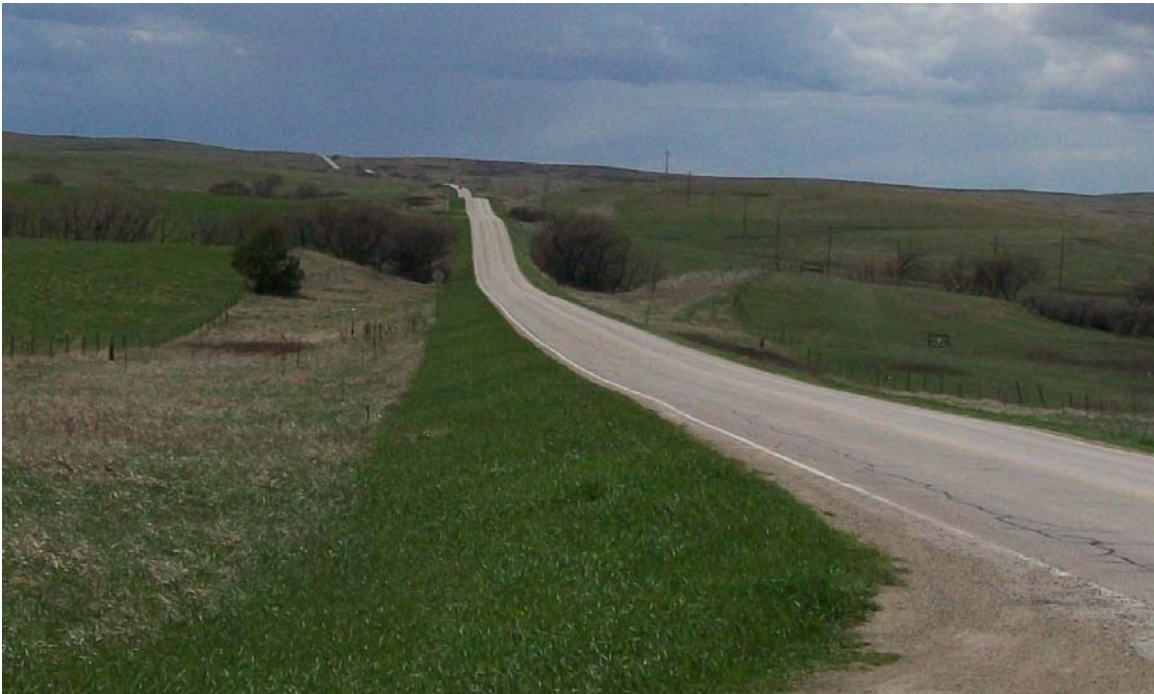
The following photos show the existing road profile with excessive vertical curves causing decreased sight distance, narrow roadway surface, lack of shoulders, steep side slopes, and heavy vegetation inside the right-of-way and clear zone. This section of roadway experiences excessive runoff road crashes.

Excessive vertical curves

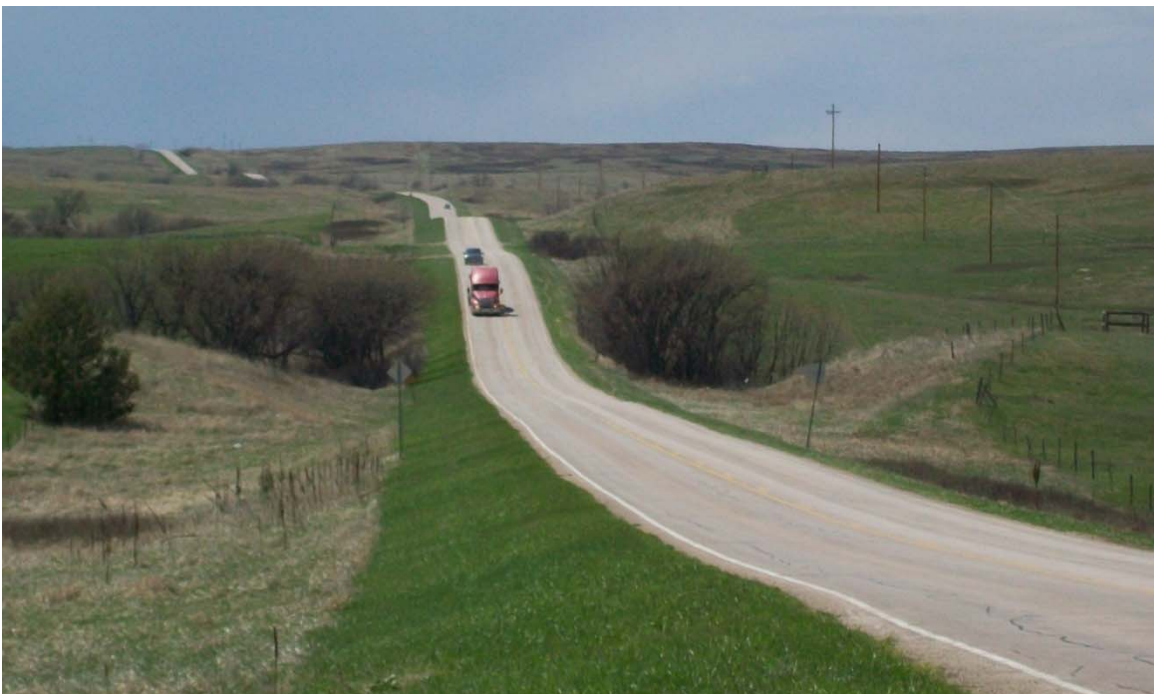
Narrow roadway with truck traffic

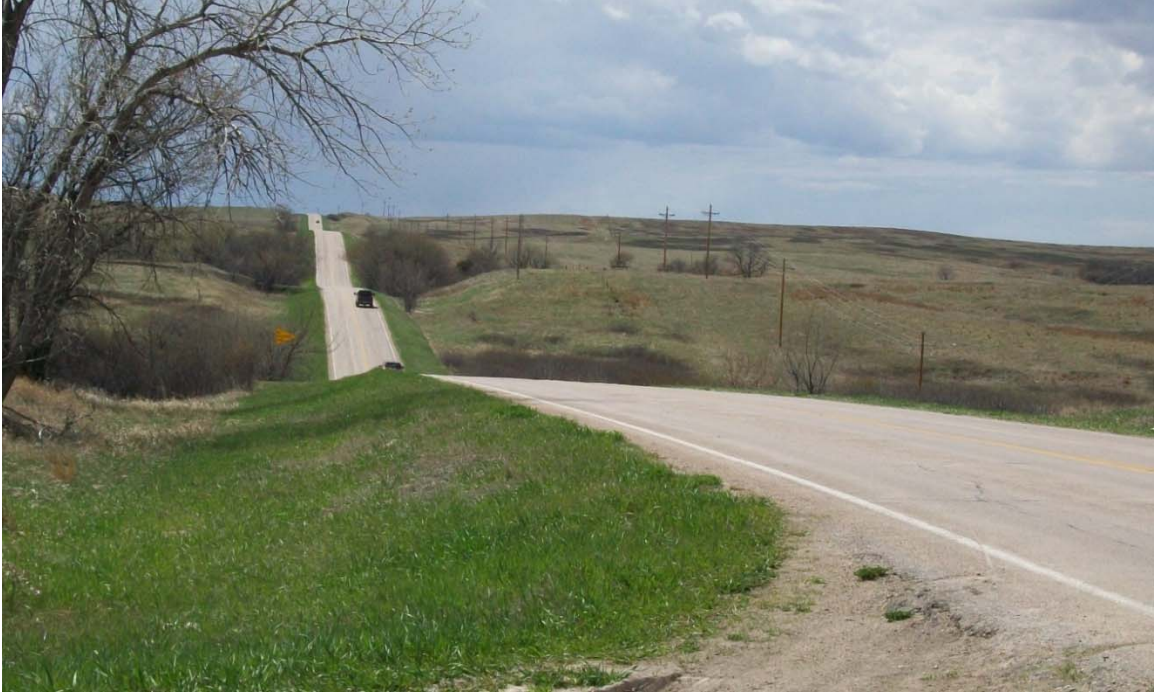
Excessive vertical curves

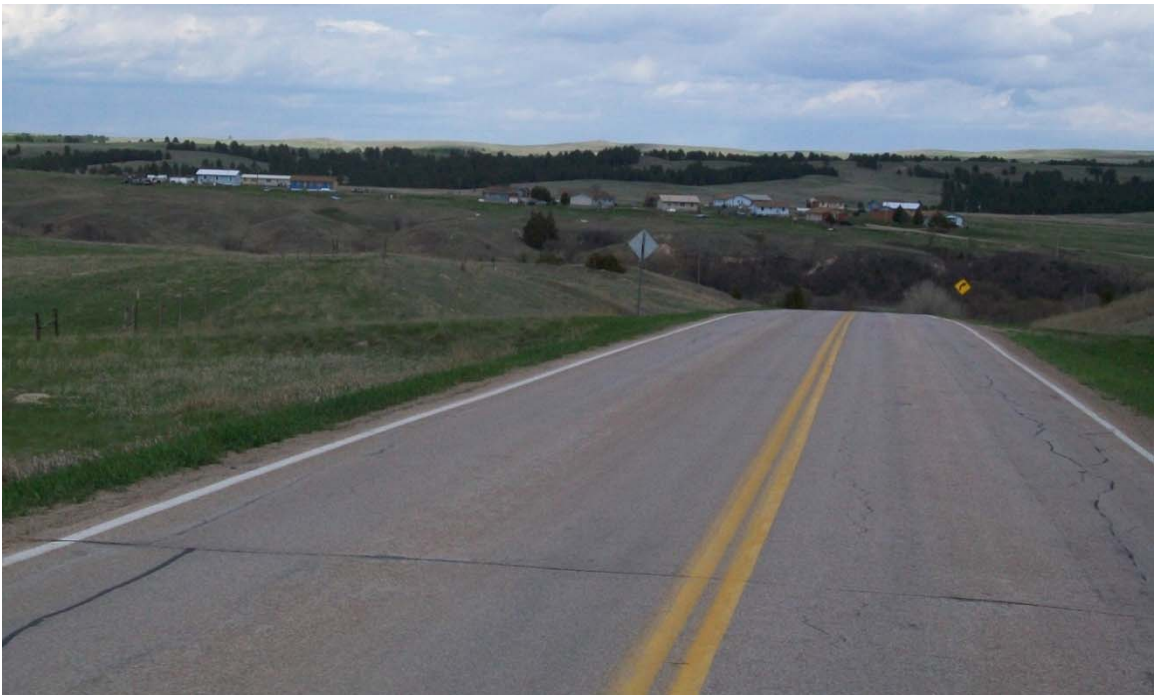
Sight distance at vertical curve

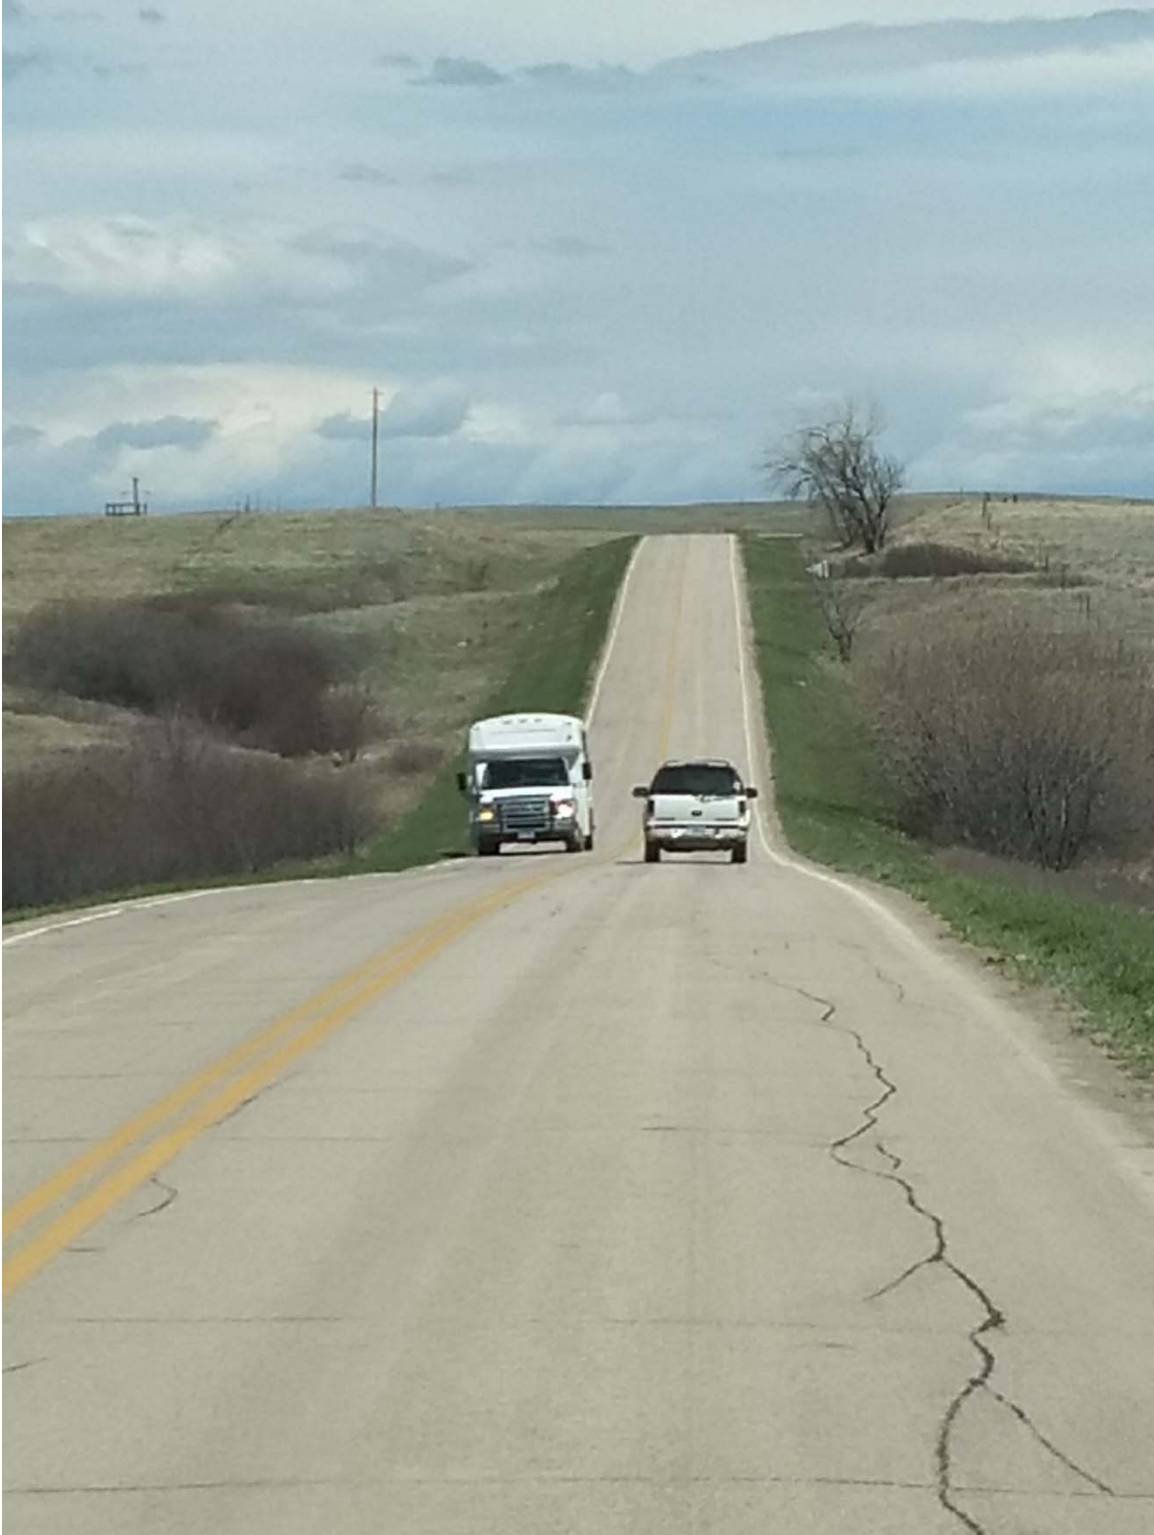
Narrow roadway for transit buses. Bus is driving on edge line.

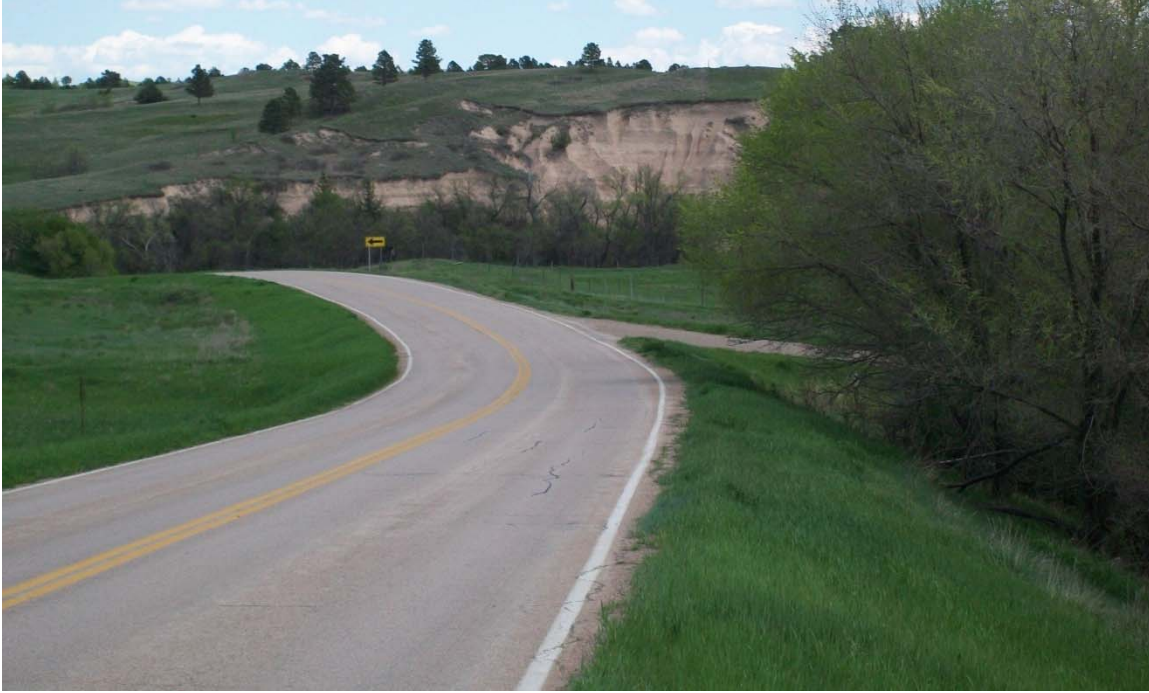
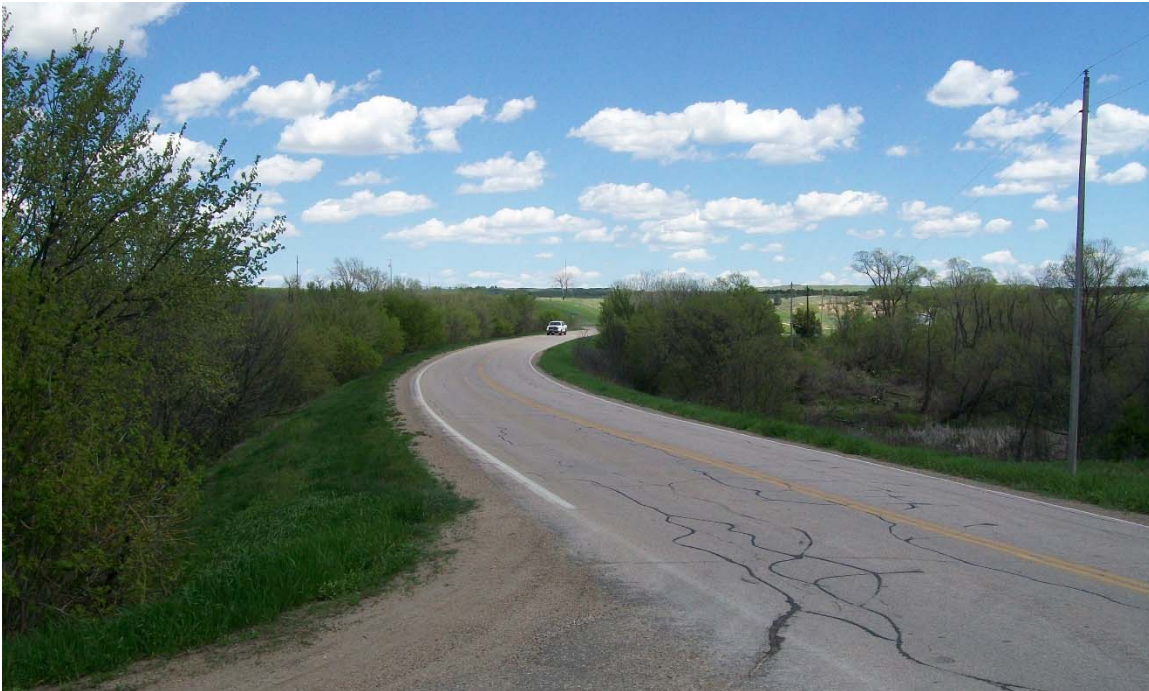
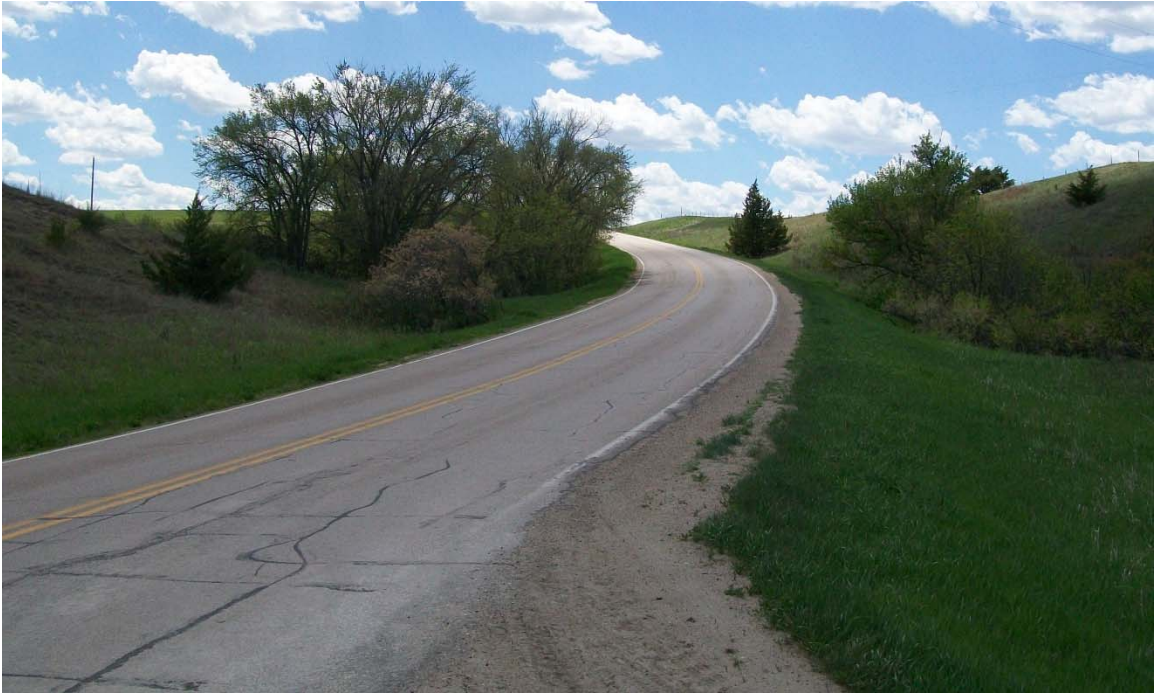
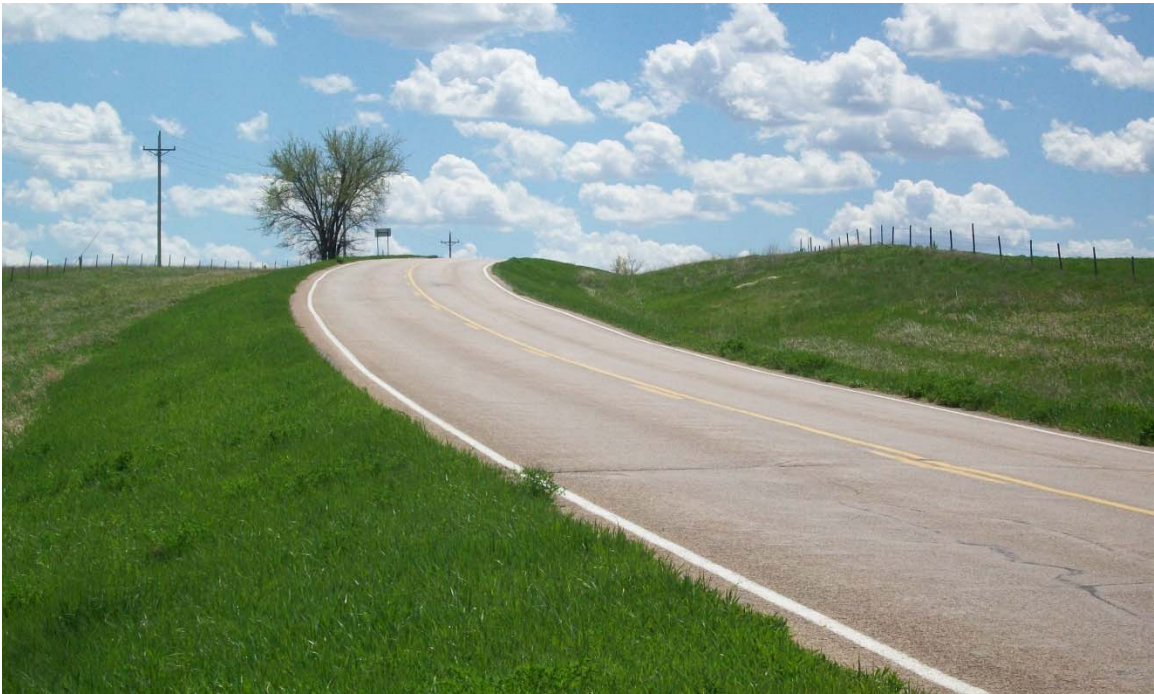
The following photos show the roadway’s sharp horizontal curves with inadequate superelevation, no shoulders and steep side slopes. Several of the horizontal curves are combined with vertical curves which reduces sight distance. Many of the curves also have trees in the right-of-way reducing sight distance and making runoff road crashes much more severe.

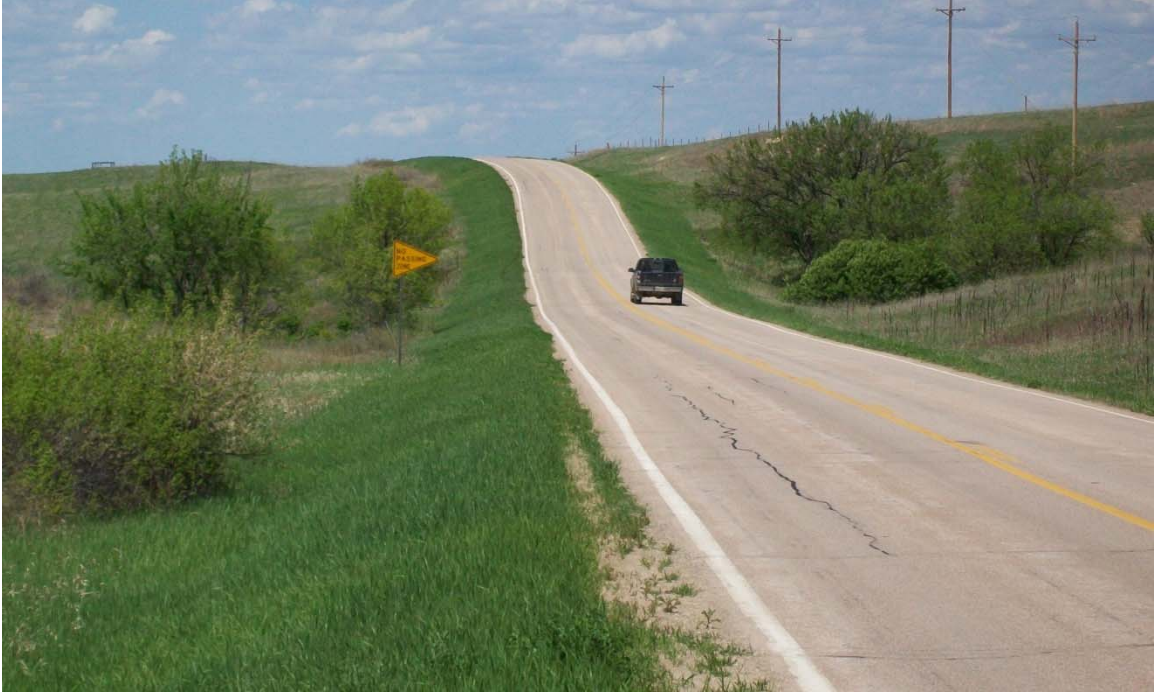
A sharp horizontal curve begins at the vertical curve crest.

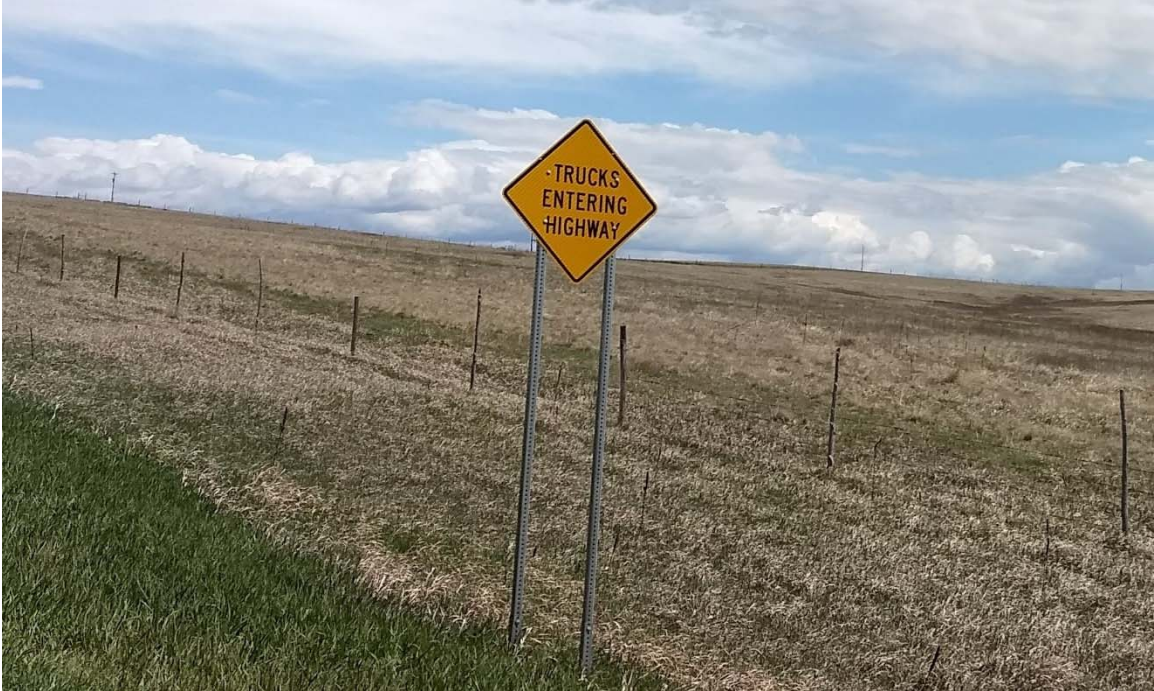
The existing roadway cross section and geometry does not support truck traffic. Most locations where trucks enter the project route do not have sufficient sight distance.

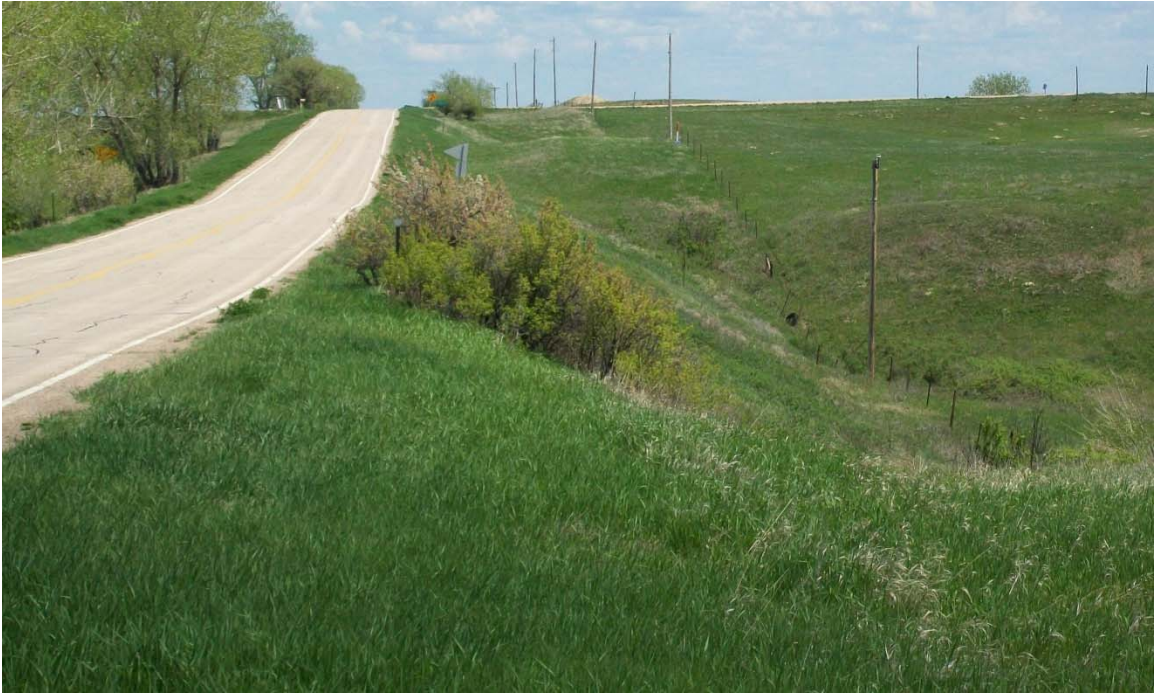
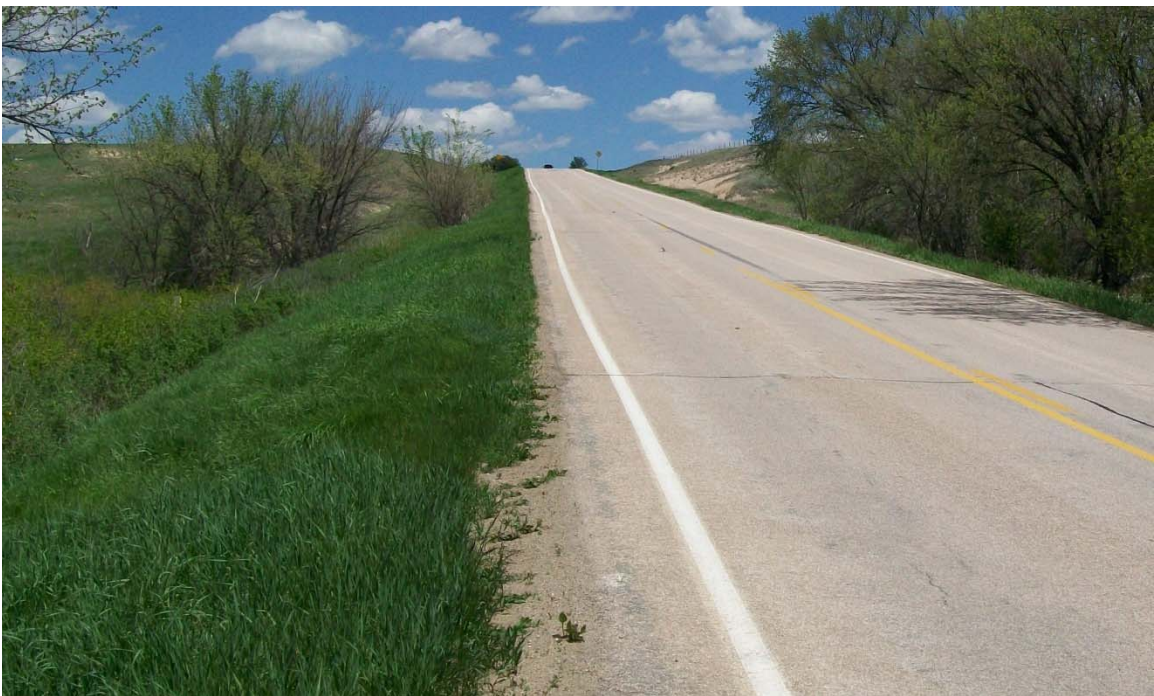
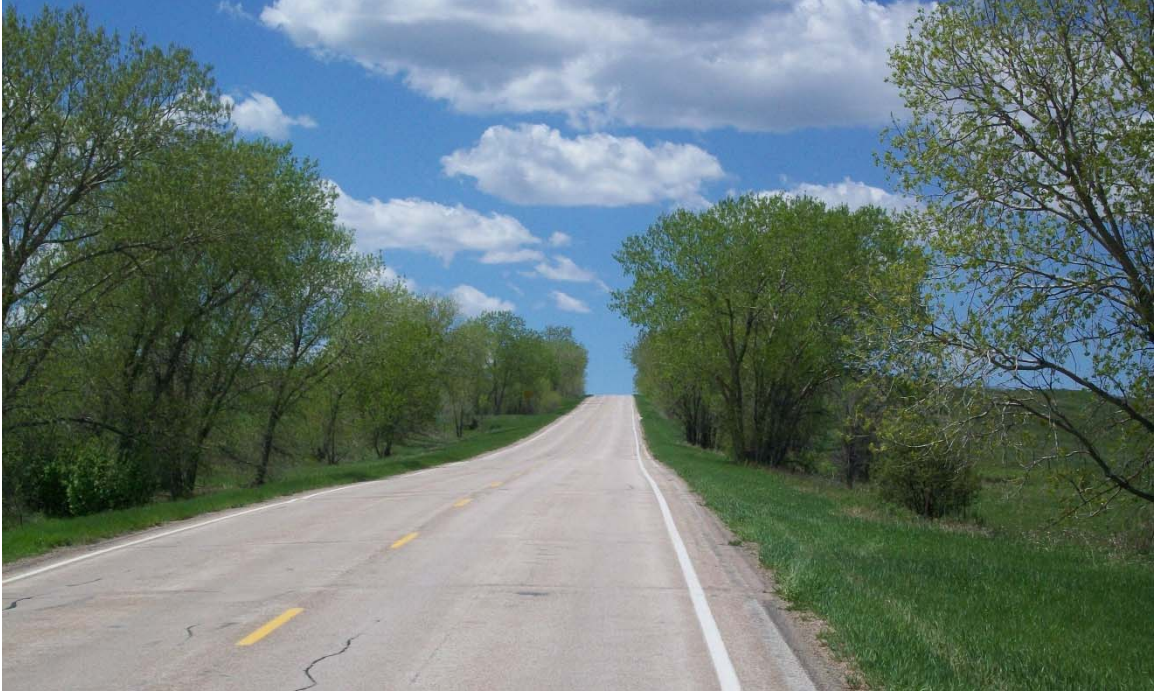
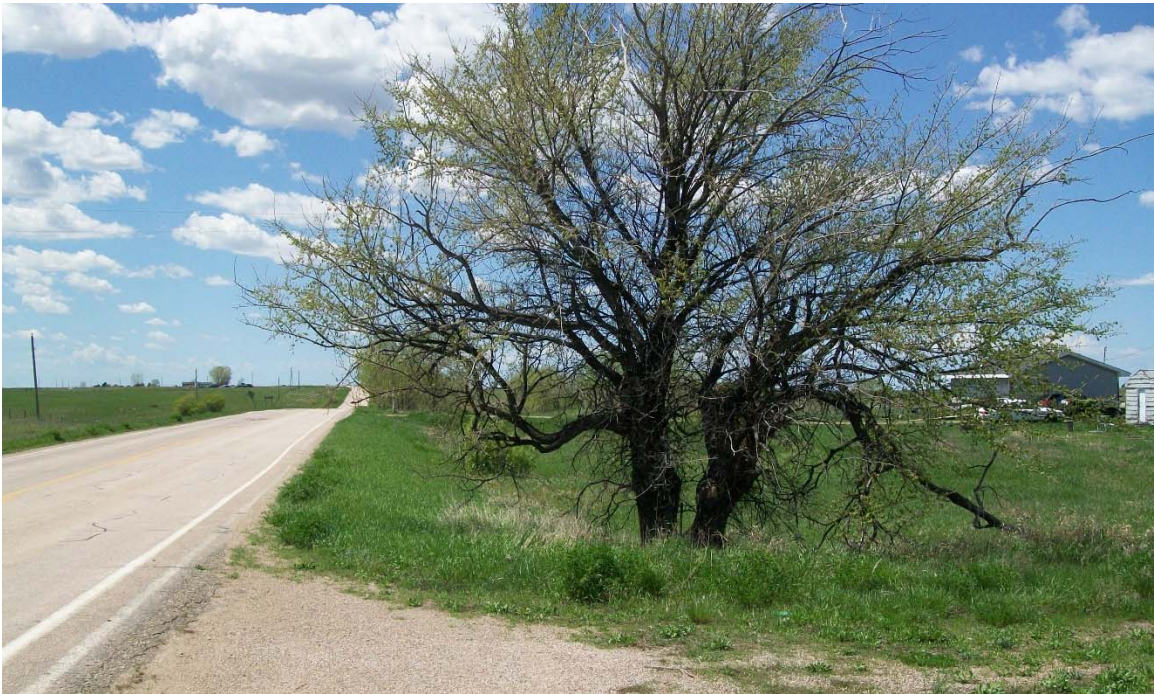
The following photos show the roadway's lack of shoulders, steep side slopes, and obstructions including trees inside the clear zone.

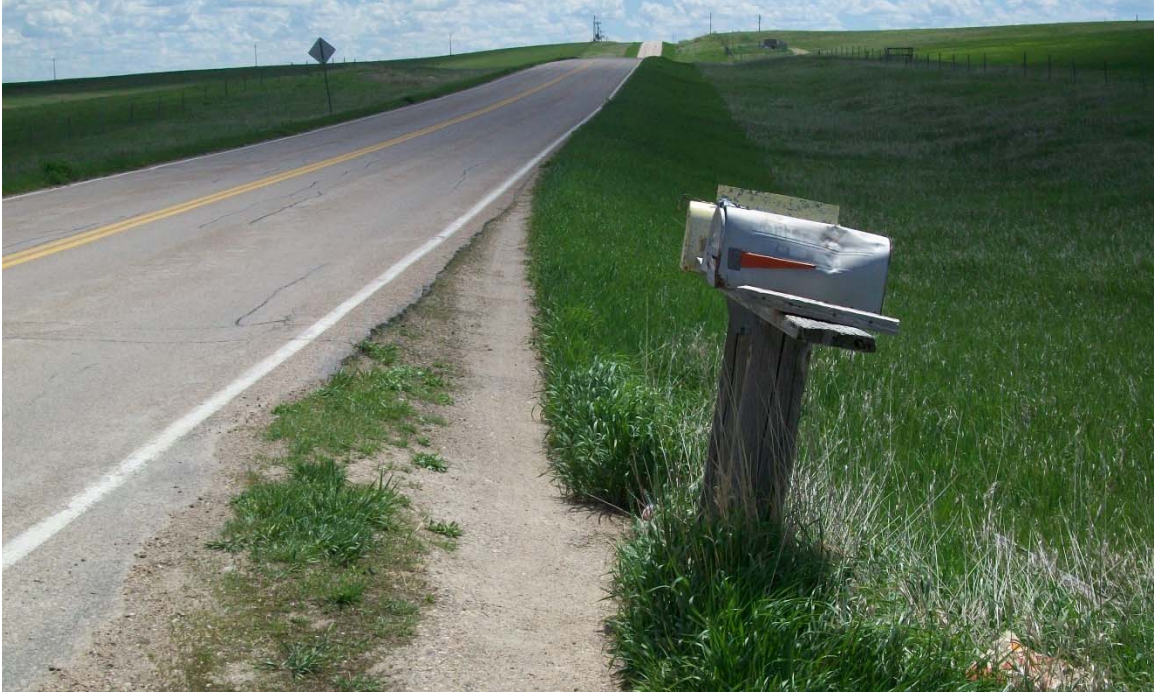
Existing mailboxes do not have breakaway bases and mail carriers must stop in roadway to deliver mail.

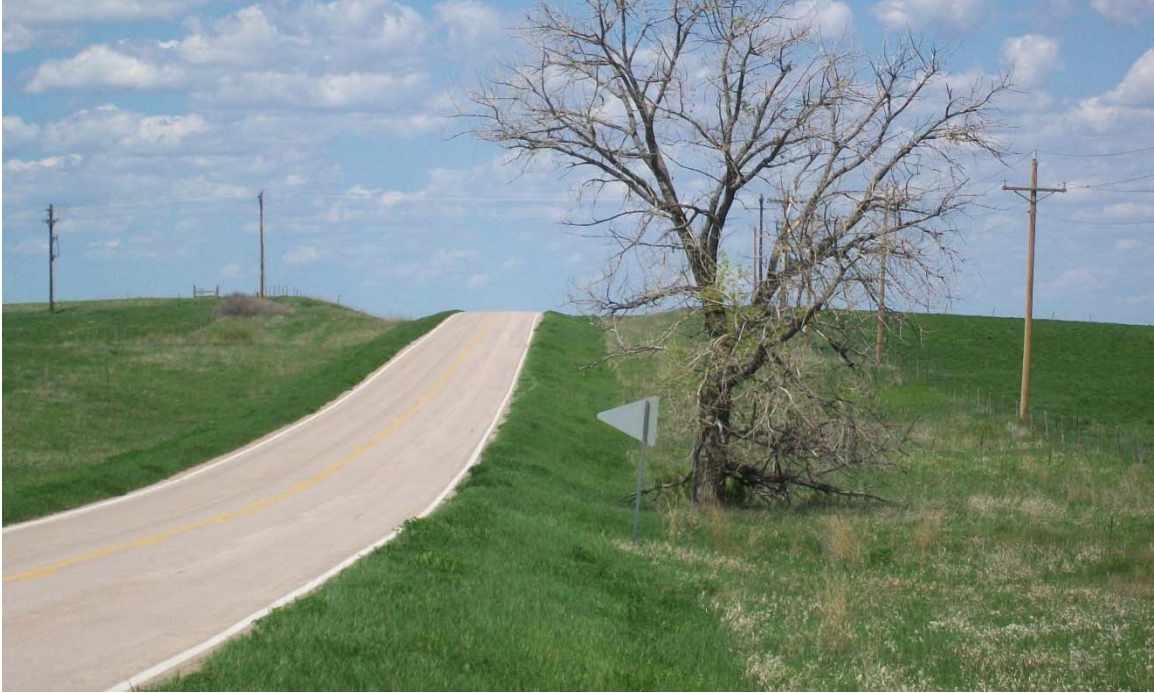
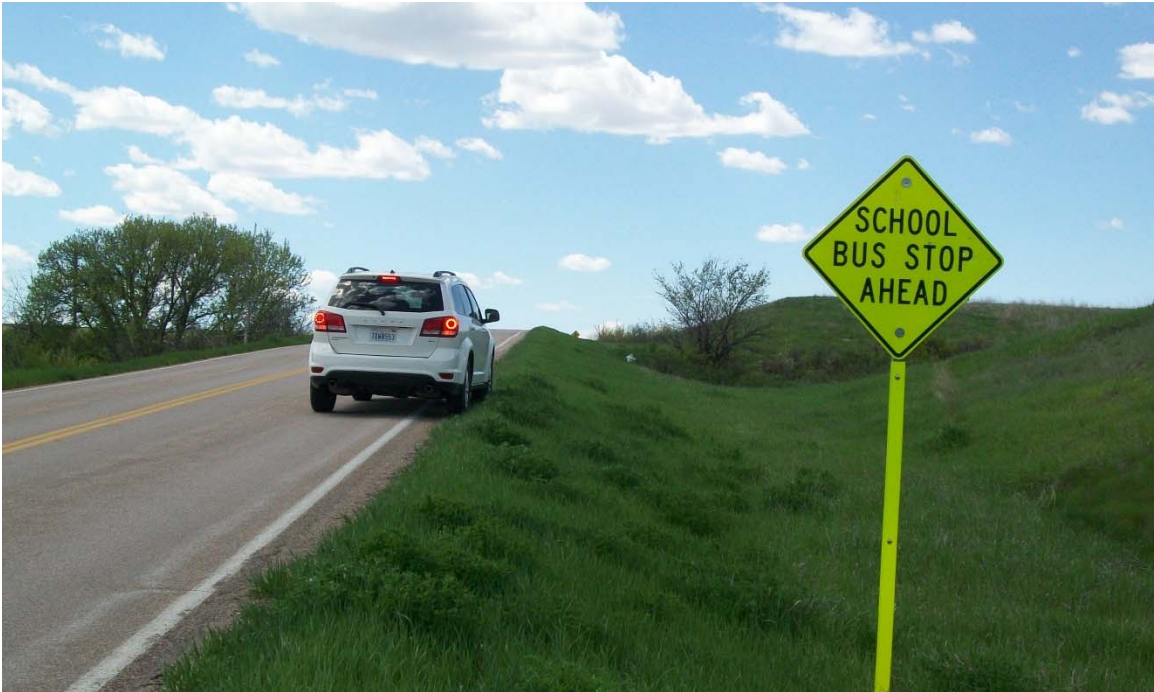
School buses make several stops along the project route. Buses stop in roadway lane due to no shoulder and steep sides slopes.

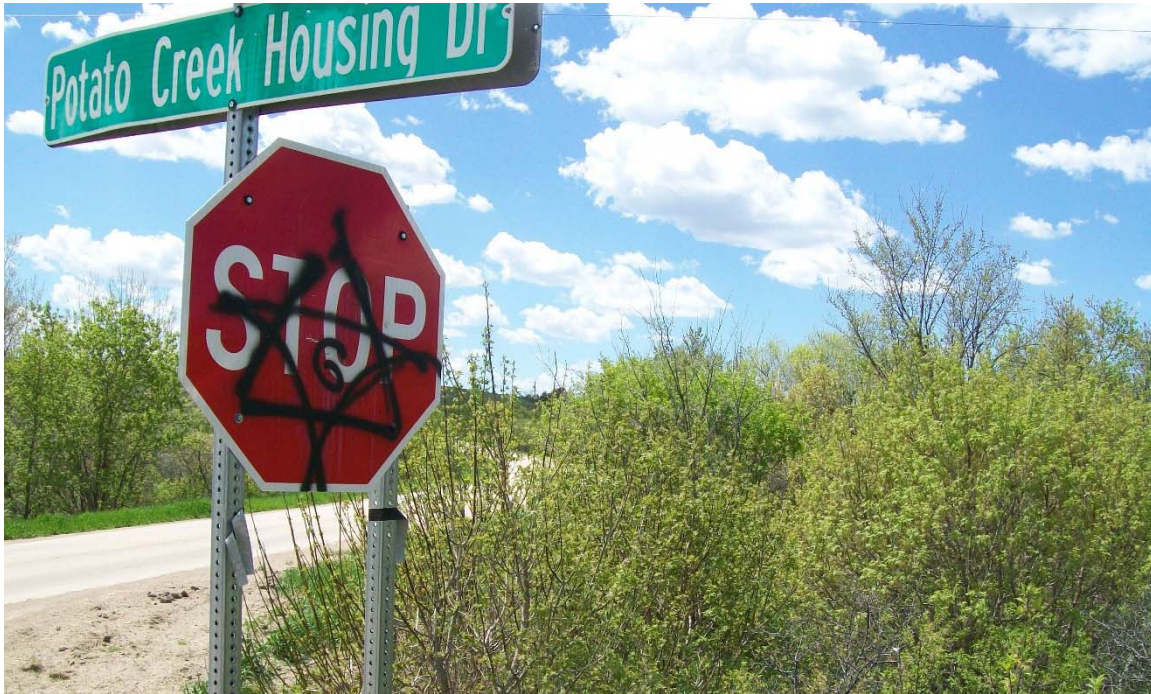
Sight distance looking west from Oglala Sioux Tribal Housing Development

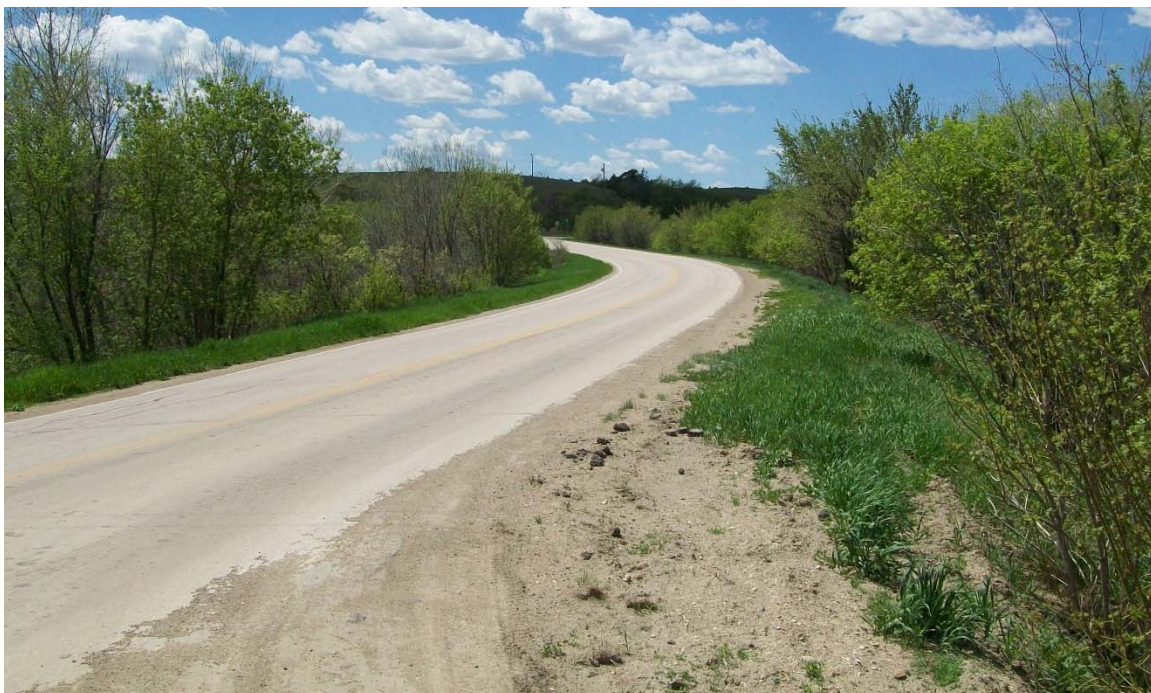
Sight distance looking west from Oglala Sioux Tribal Housing Development

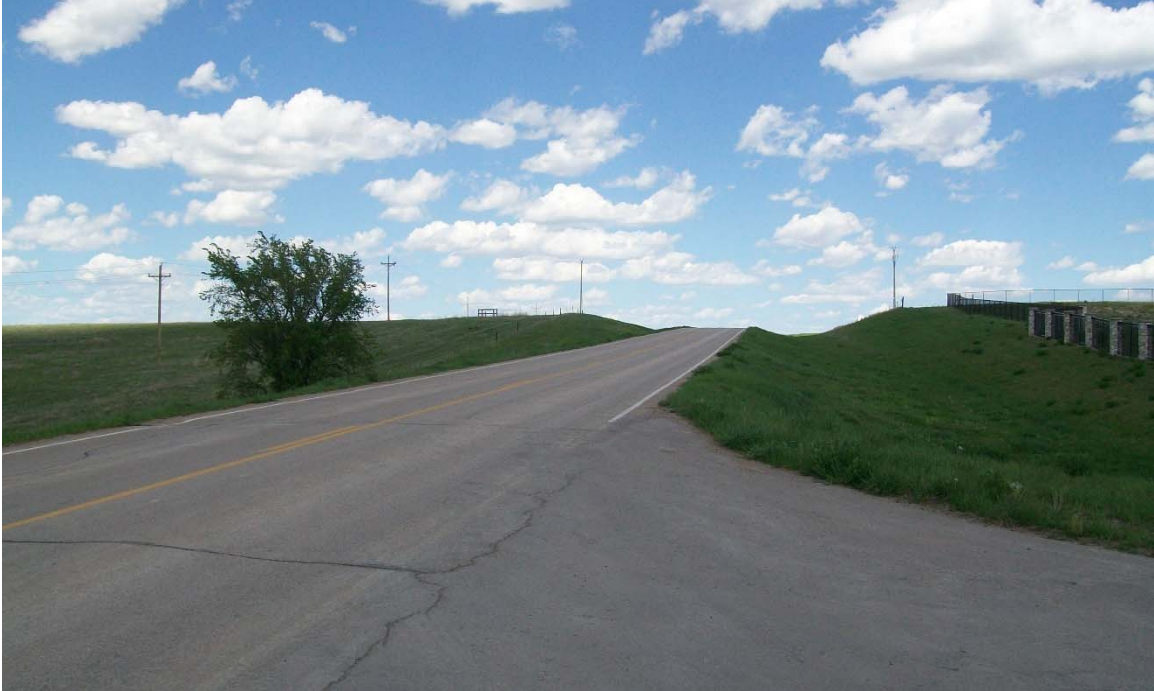
Sight distance looking east from the Lakota Freedom Veteran’s Cemetery

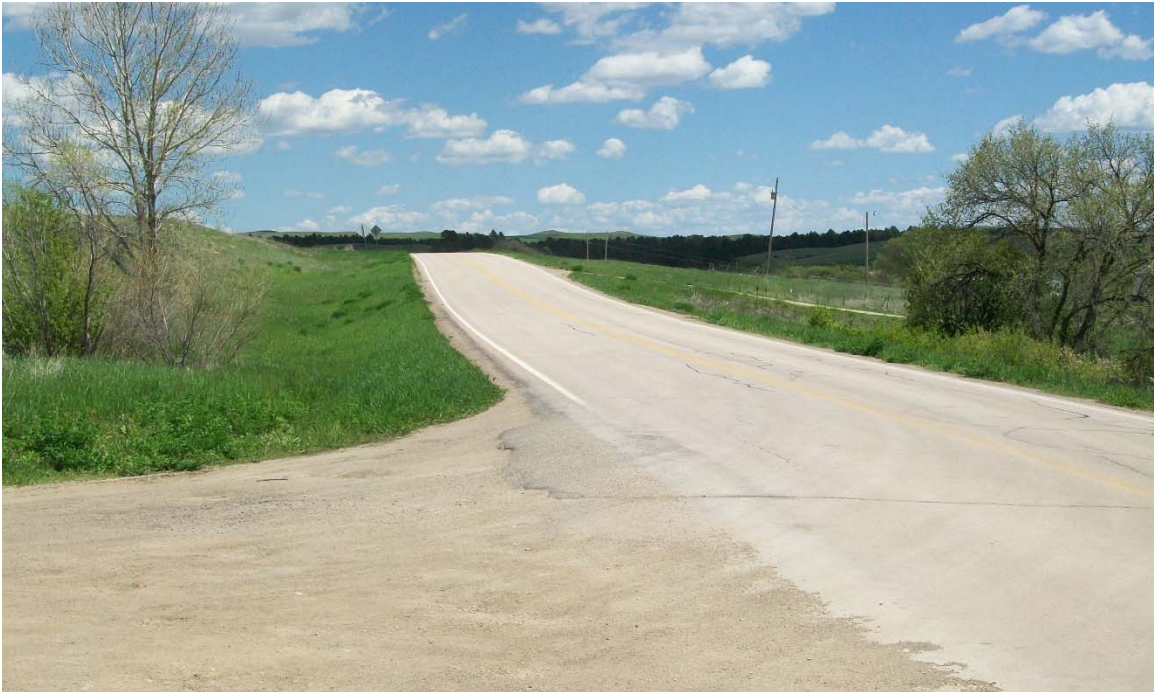
Sight distance from an intersecting road

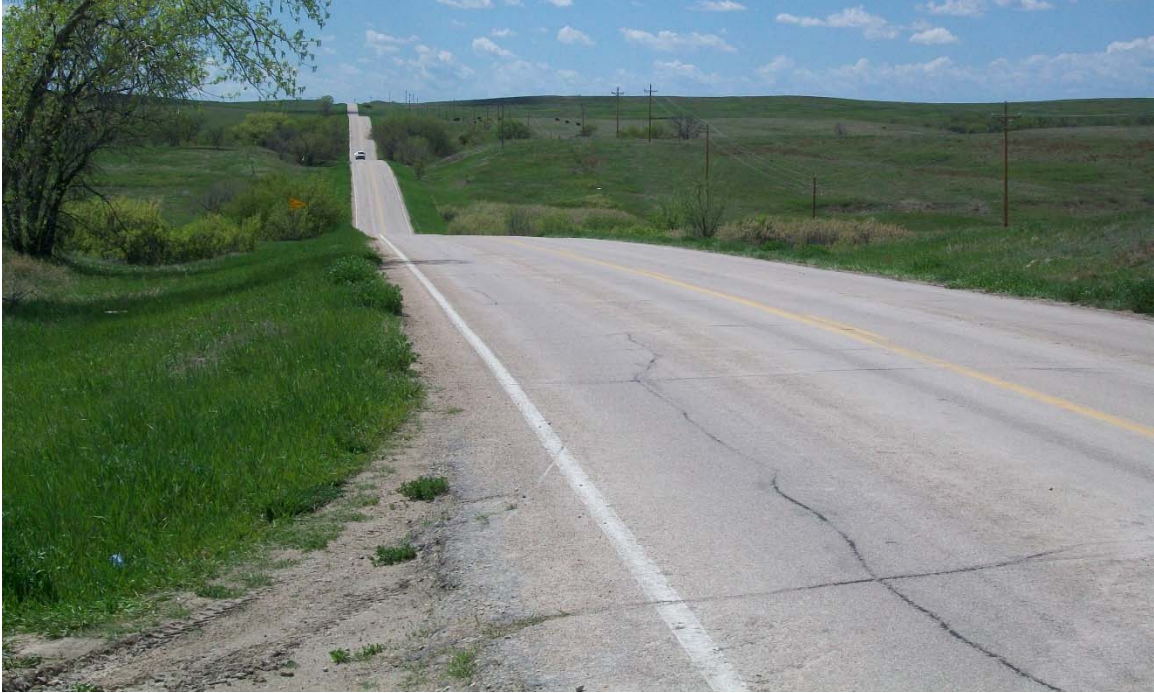
Sight distance from an intersecting road
