BIA 2 – Rural Safety and Regional Access Project  
BIA 2 Site Photos – Rural Section

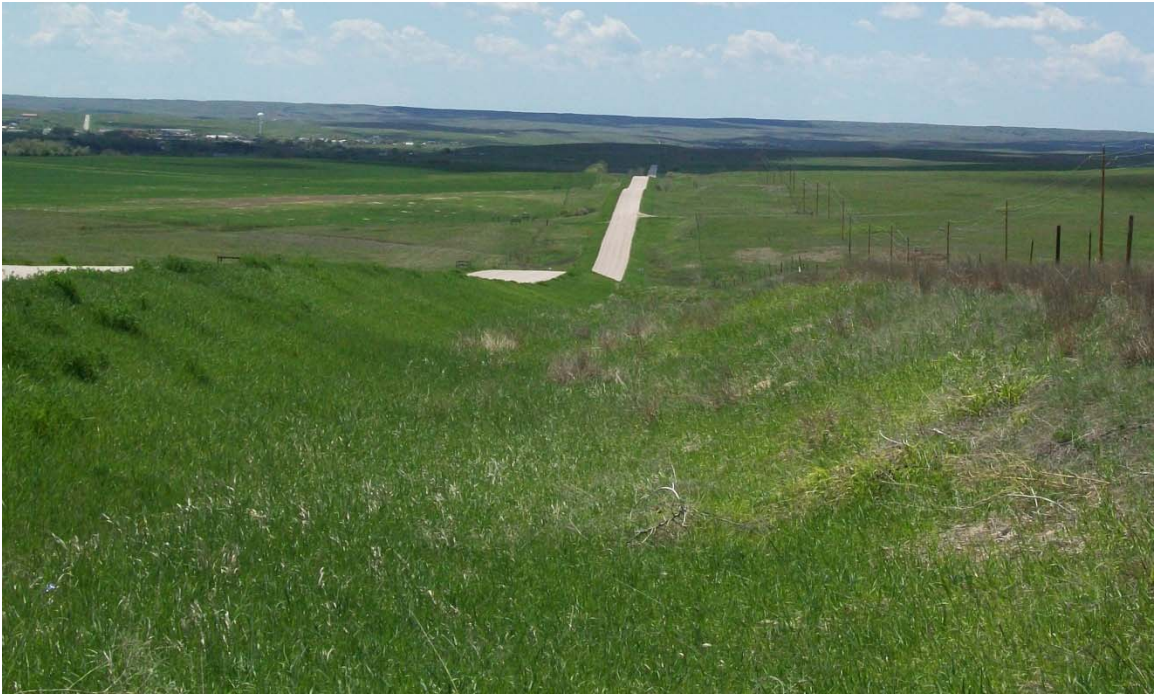
Sight distance from an intersecting road

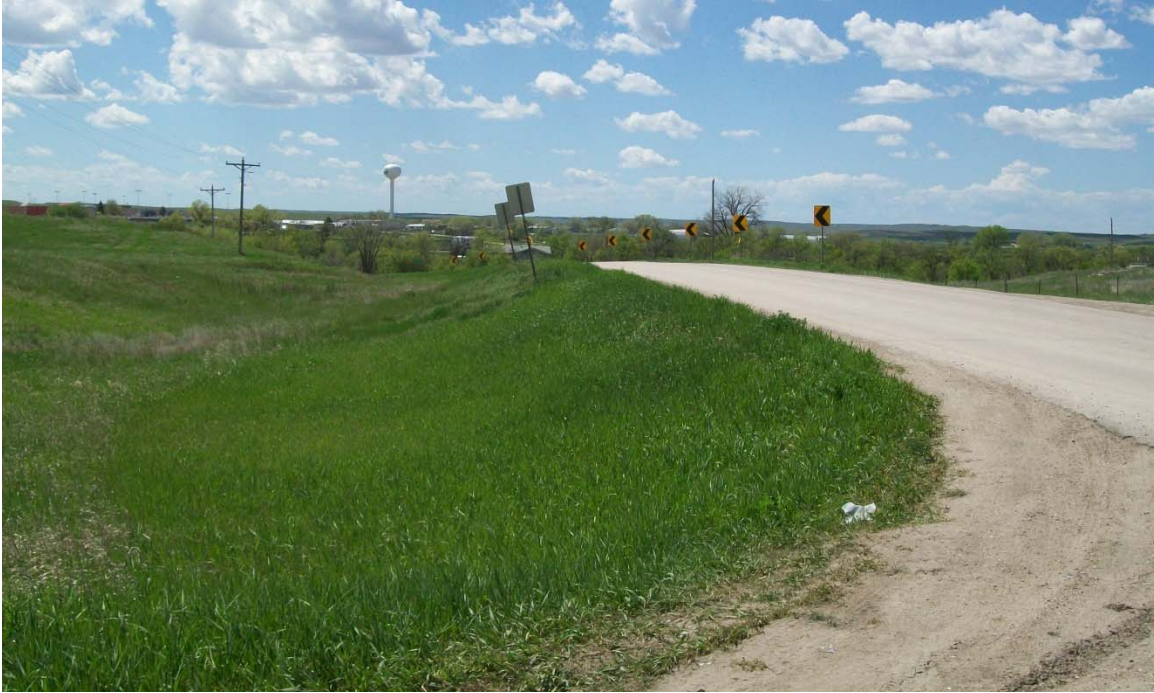
Sight distance from an intersecting road

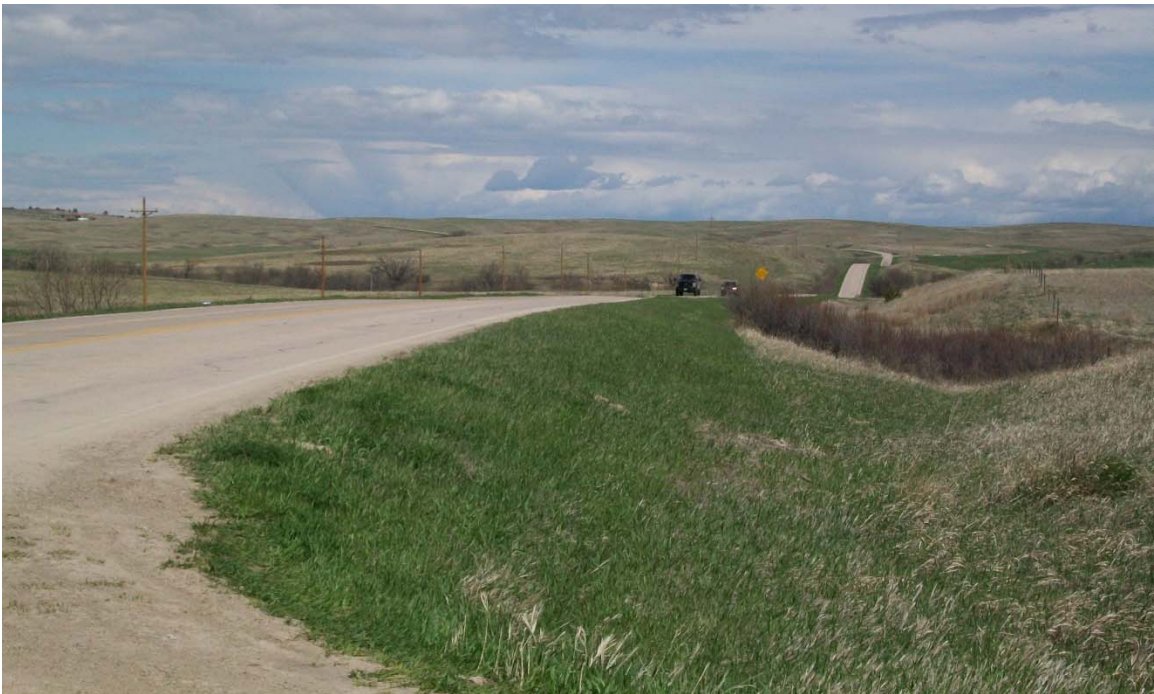
Sight distance from an intersecting road

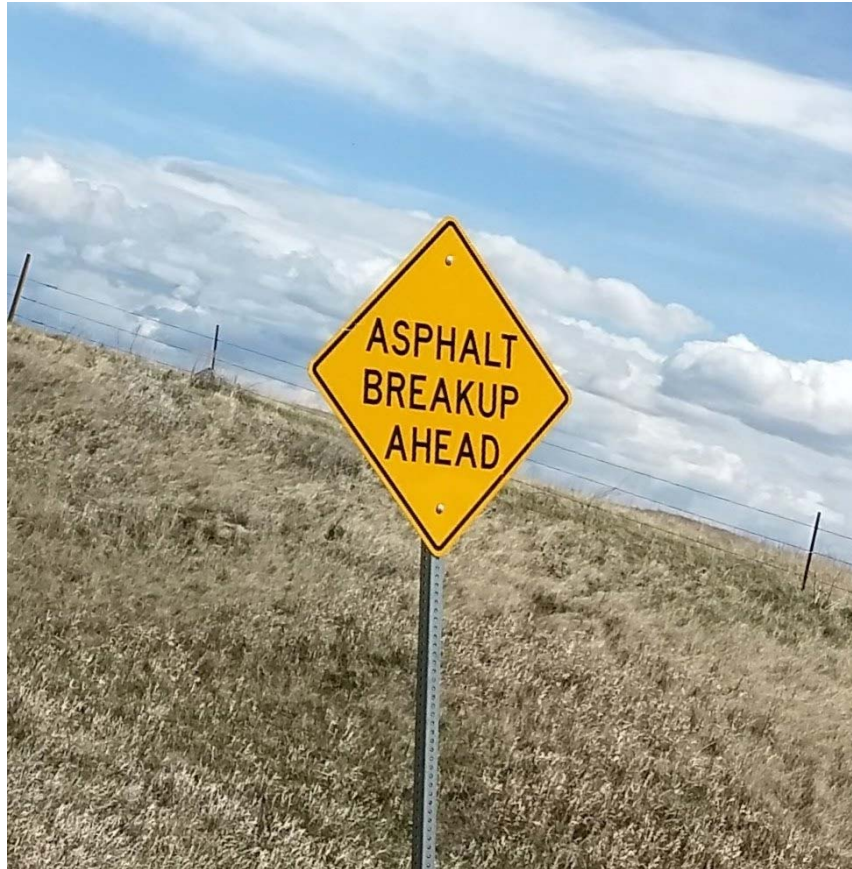
Asphalt breakups along the project route

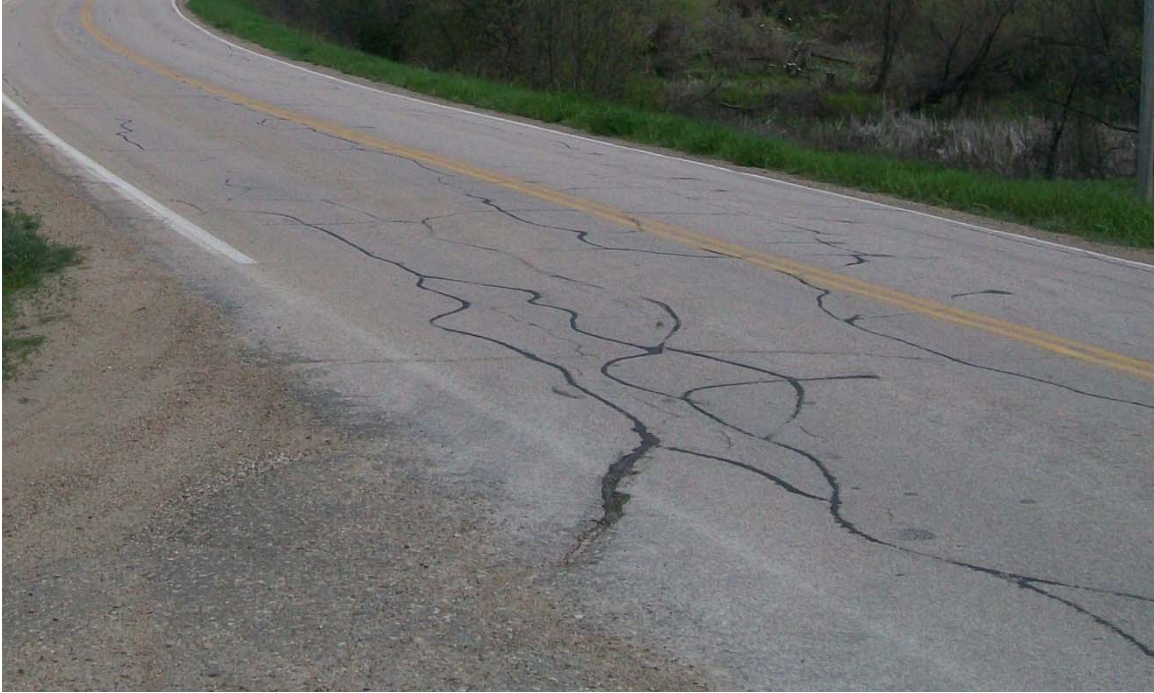
Crack Sealing is excessive due to asphalt pavement age
