STRUCTURE IDENTIFICATION AND LOCATION

Structure Name: Potato Creek State: 46 - South Dakota

Feature Crossed: Potato Creek

Agency: A06 - Pine Ridge Reservation: A06344 - Pine Ridge

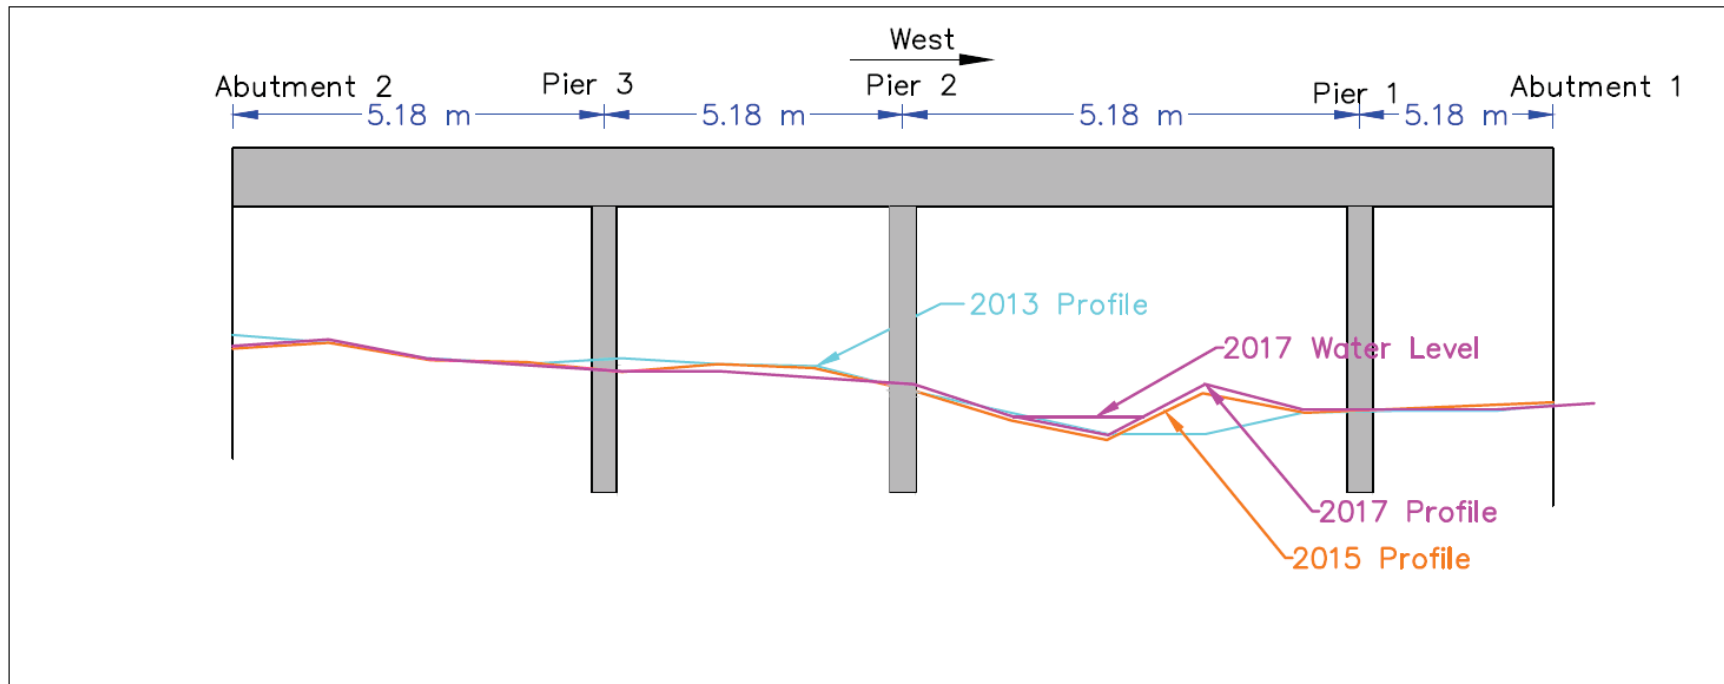
A028 CHANNEL PROFILE

Station (m)	0.0	1.5	3.1	4.6	6.1	7.6	9.1	10.7	12.2	13.7	15.2	16.8	18.3	19.8	21.3
Vertical (m)	3.1	3.0	3.3	3.4	3.5	3.5	3.6	3.7	4.2	4.5	3.7	4.1	4.1	4.1	4.0

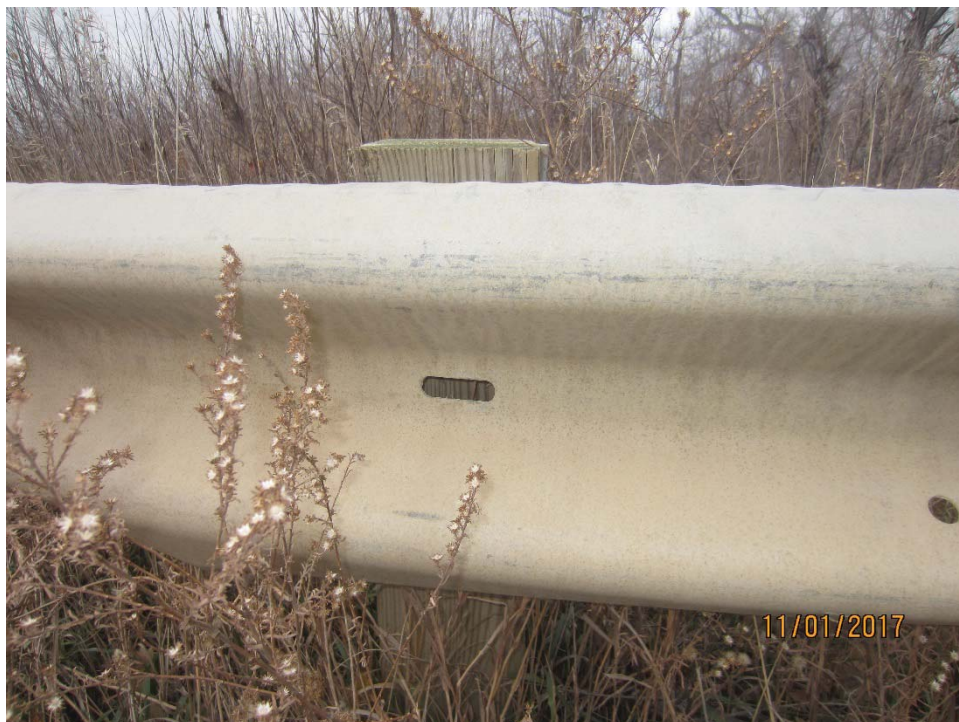
1101 Description: NE guardrail radius in missing bolt. Recommend realign post and installing bolt.

Missing bolt in guardrail

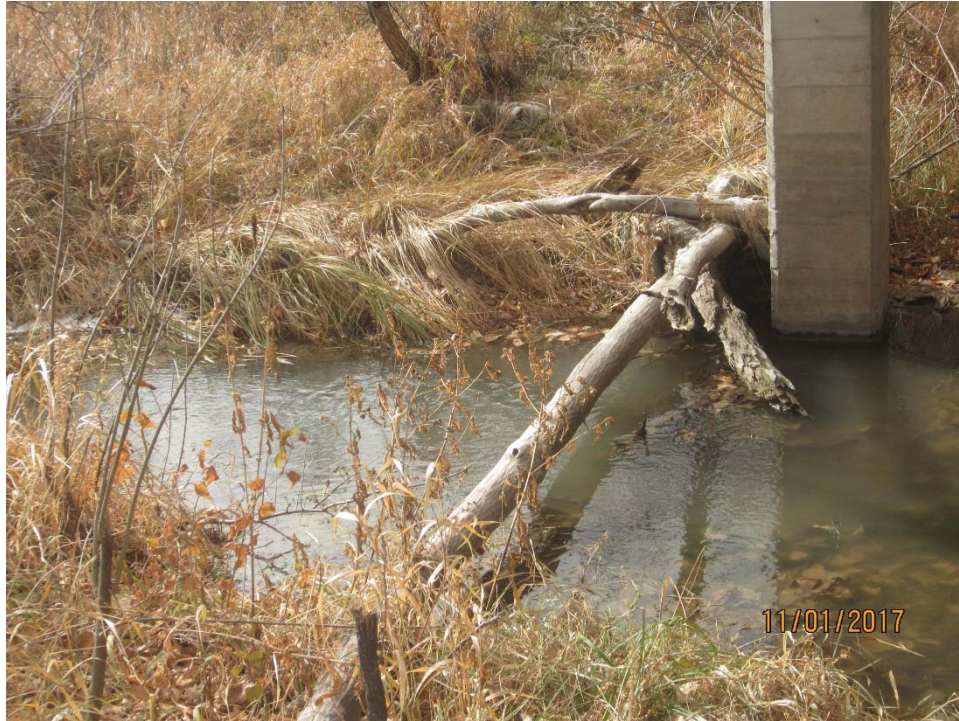
P8A Description: Moderate timber debris accumulated on south side of bridge along channel. More concentrated between Piers 1 and 2. Recommend removing timber debris.

Channel Debris

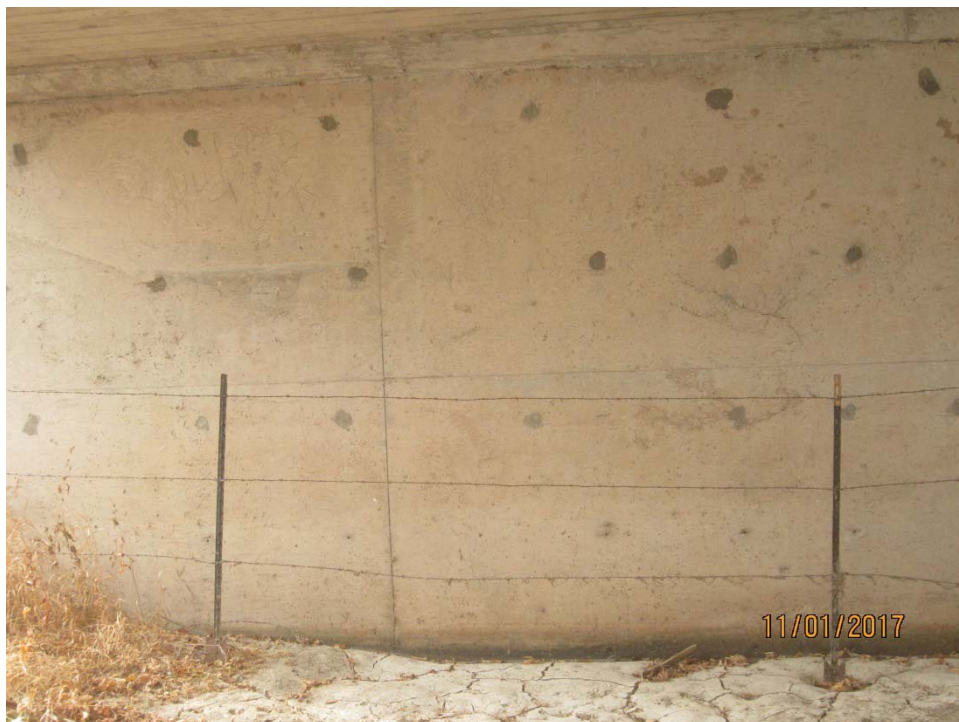
Cracking on S abutment

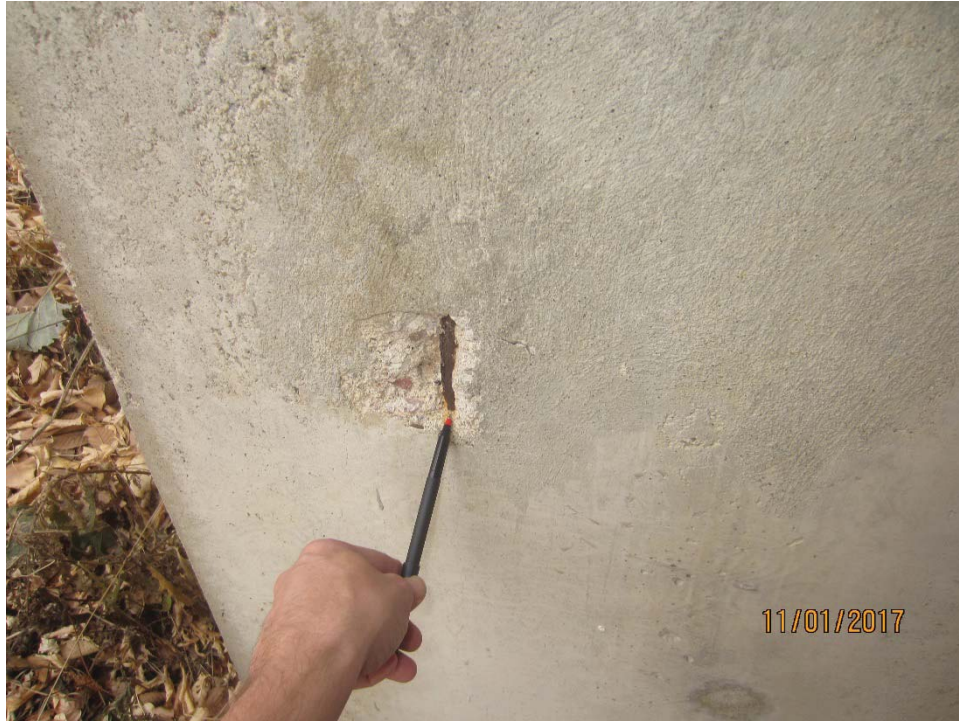
1011 Description: Abutment 2 has several superficial vertical cracks up to 0.4m wide x full height. Patch is failing, exposing 50mm of one rebar. No action required.

Exposed reinforcement on north end of east abutment

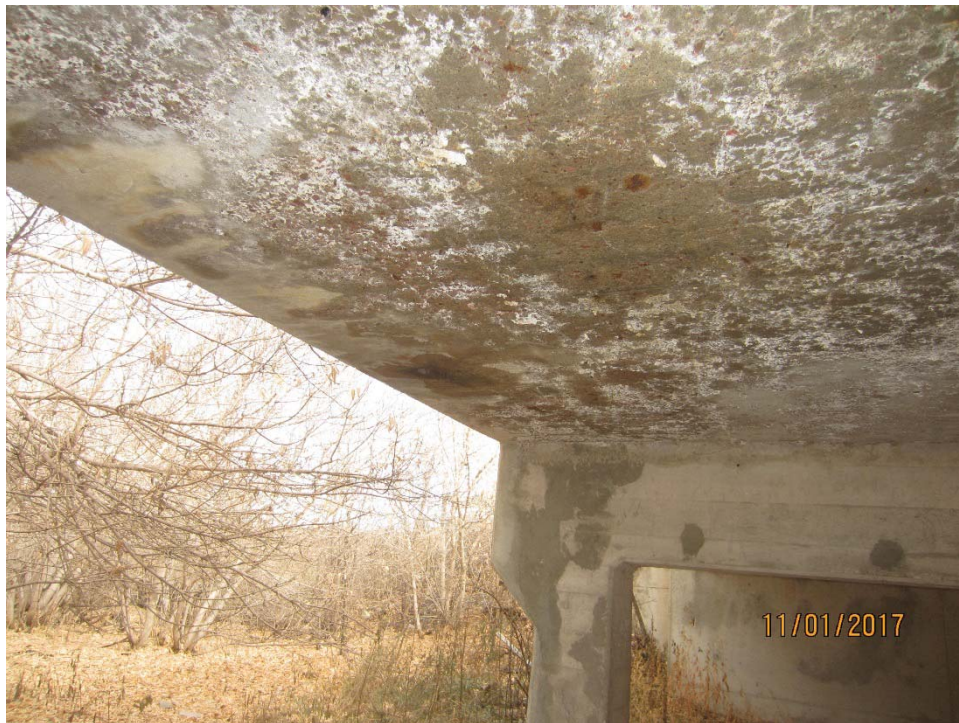
Bottom of slab water damage from drains

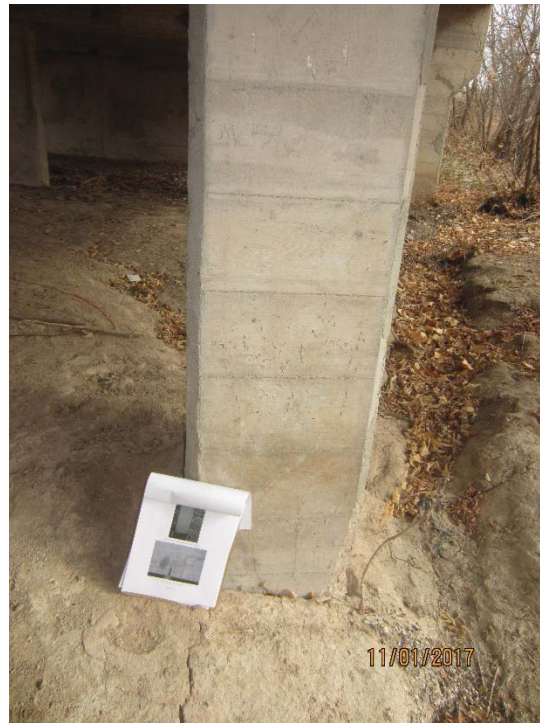
1007 Description: Pier 2 column 1, vertical/diagonal cracks, all faces, up to 0.8mm wide and an impending spall w/ delamination, north face, 1m high x 0.4m wide. Columns 2 and 3 have vertical cracks up to 0.4mmx7mm. No action required.

Typical pier column condition

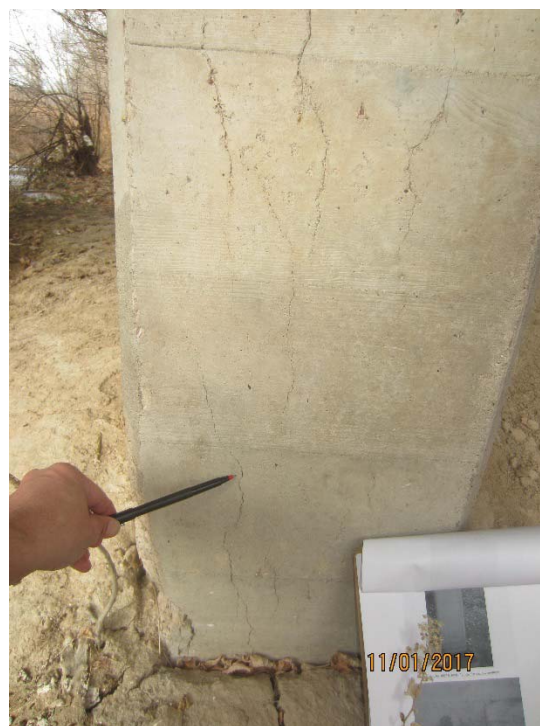
1009 Description: Pier Caps 3 and 4 have vertical cracks up to 0.4mm wide x full height. Monitor for changes.

Pier cap cracking

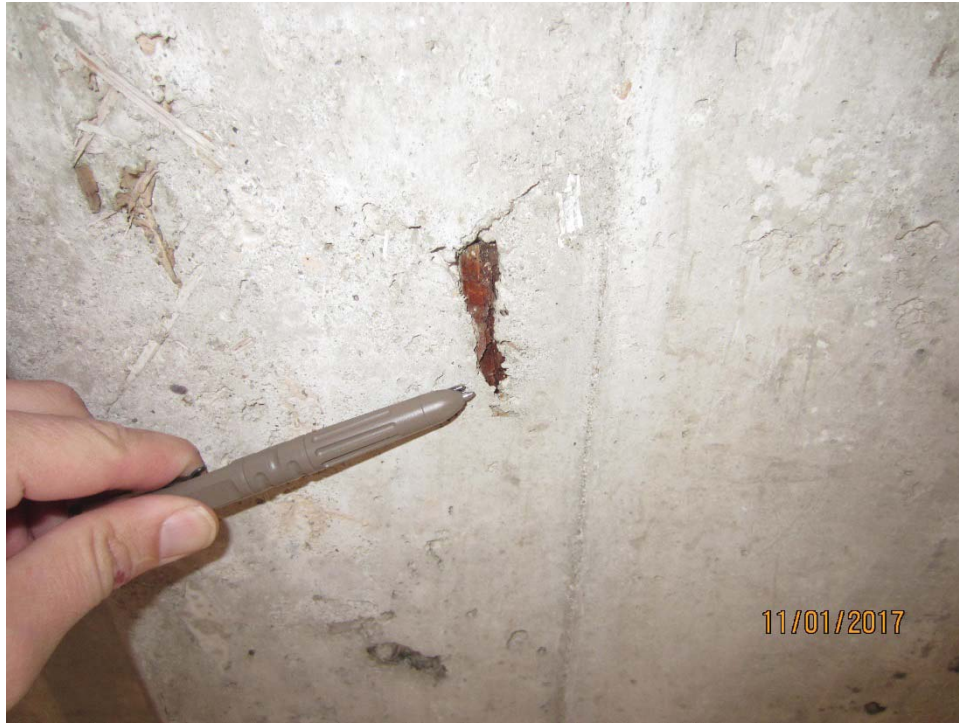
Hole in Beam

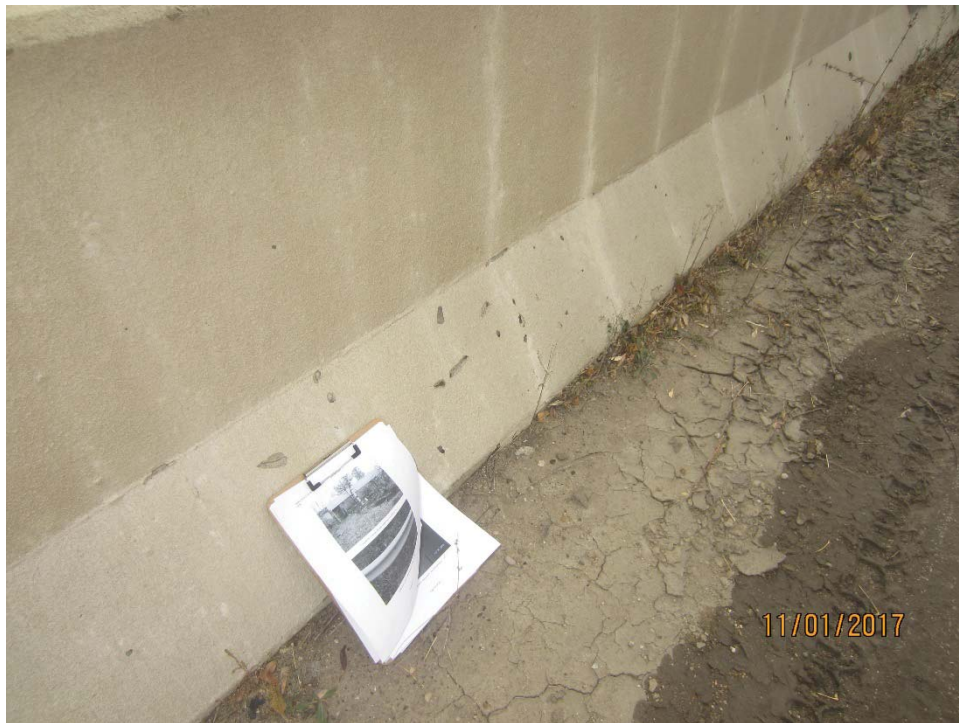
1502 Description: Surface finish failing on barrier. No action required.

Surface finish peeling on bridge rail

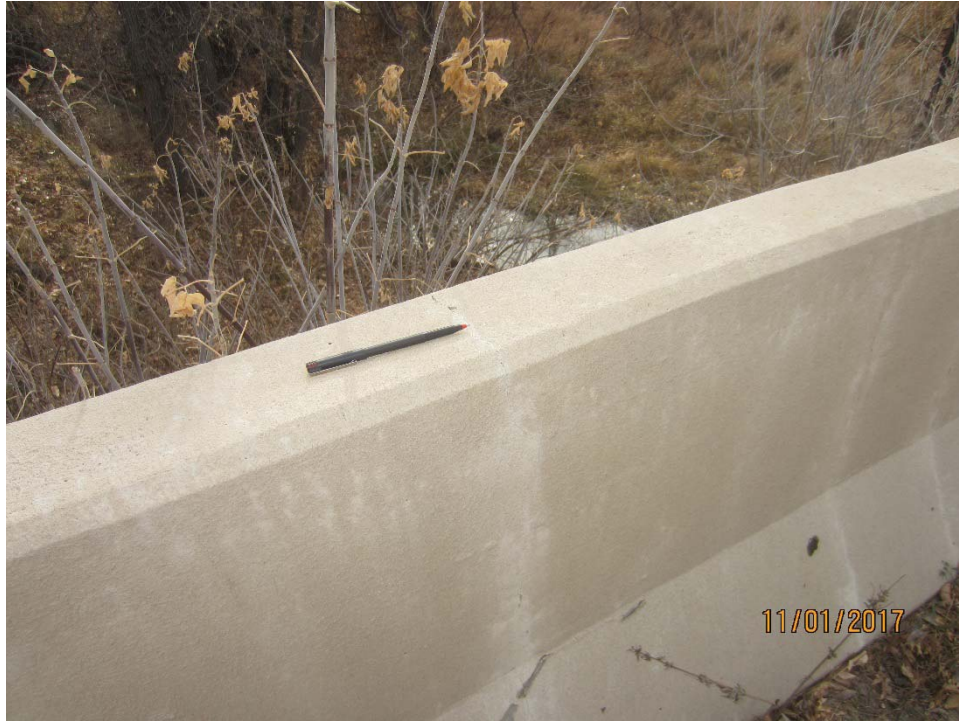
1501 Description: Vertical cracks at regular 2' intervals throughout barrier interior. Surface finish failure. No action required.

Cracks on guardrail

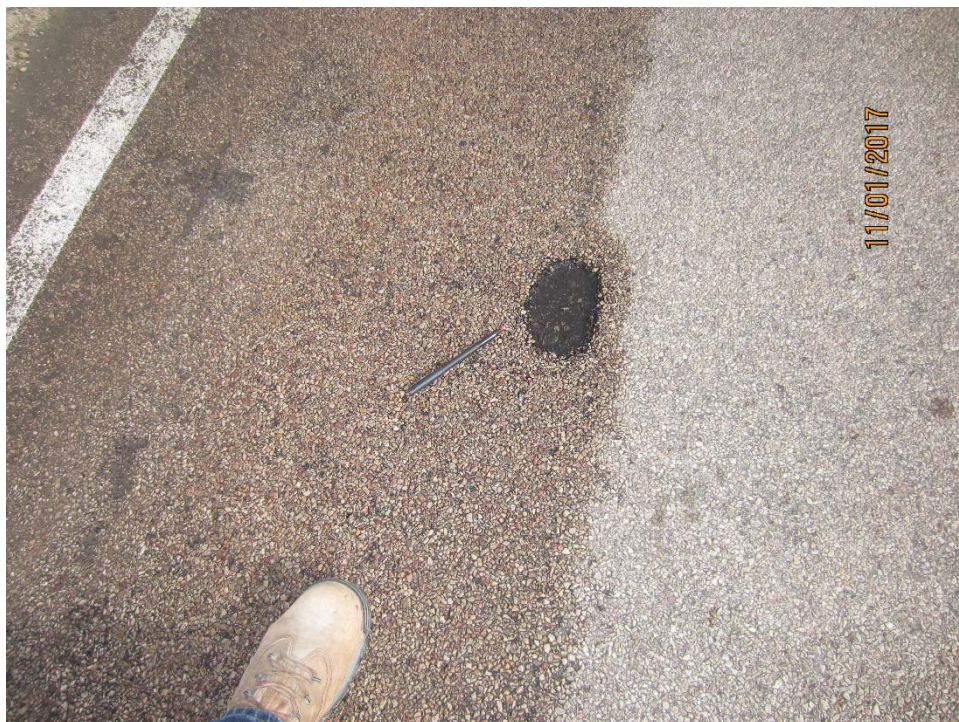
Asphalt overlay failing.
