# 2018 ROAD SAFETY AUDIT

Oglala Sioux Tribe

*July 2018*

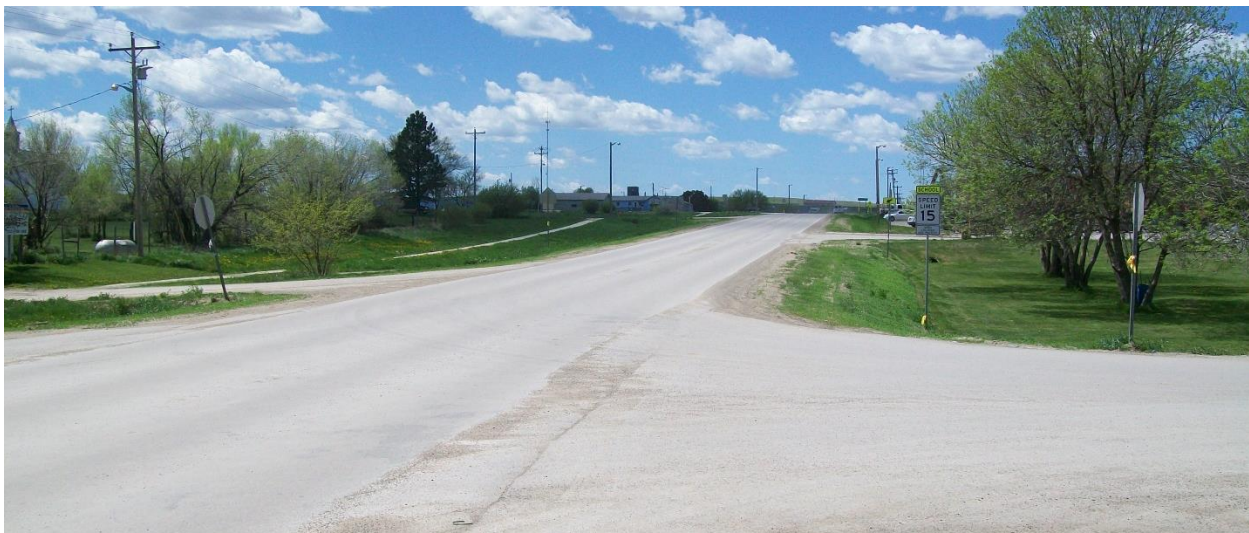
*Figure 3.1: BIA 2 Urban Section within School Zone*

The existing paved roadway is approximately 24-feet wide with two 12-foot travel lanes and no shoulders. There is very limited pedestrian facilities along this urban section and areas with current facilities are not ADA compliant. There are many private and public approaches along both sides of the road. The urban section of BIA 2 has a posted speed limit of 40 mph towards the outer edges of town then dropping to 25 mph and 15 mph for school zones closer to the center of the town.

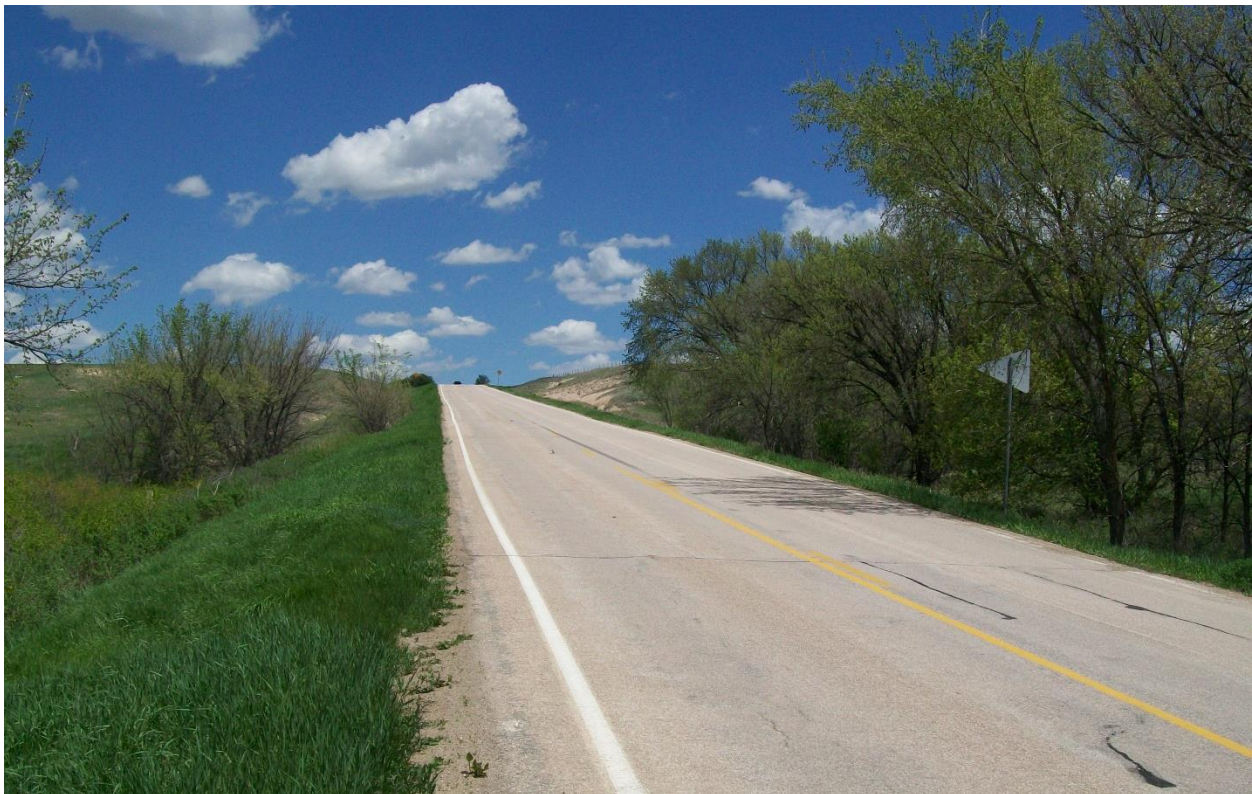
*Figure 3.2: BIA 2 Rural Section with Steep Side Slopes*

The rural section of BIA 2 begins on the east end of Kyle and travels easterly for approximately 18.8-miles to the intersection of BIA 2 and State Highway 44. The existing paved roadway is approximately 24-feet wide with two 12-foot travel lanes and no shoulders. BIA 2 has steep side slopes, tight horizontal curves, excessive vertical curves, and many trees within the roadway clear zone. Additionally, due to the vertical curves and trees within the roadway clear zone, most of the roadway intersections have insufficient sight distance. BIA 2 rural section has a posted speed limit of 55 mph and many of the curves are too sharp for the current posted speed limit.

As a result, there have been numerous crashes and reports by residents, tribal agency personnel, and emergency management of avoiding the route, especially at night due to the potential for crashes. The roadway was last constructed approximately 40 years ago and does not meet the current safety standards for width, shoulders, recoverable side slopes and clear zone.

The roadway asphalt is nearing the end of its design life and will need to be milled and overlaid within the next 5-10 years. An asphalt overlay would build up from a thin asphalt layer and the edges would be tapered causing the road to be further narrowed. Many paved routes on the Pine Ridge Indian Reservation have shoulder rumble strips installed. Installing rumble strips to prevent run off road crashes is a high positive impact per dollar spent for the improvement. Unfortunately, BIA Route 2 at its current width is too narrow for rumble strips.

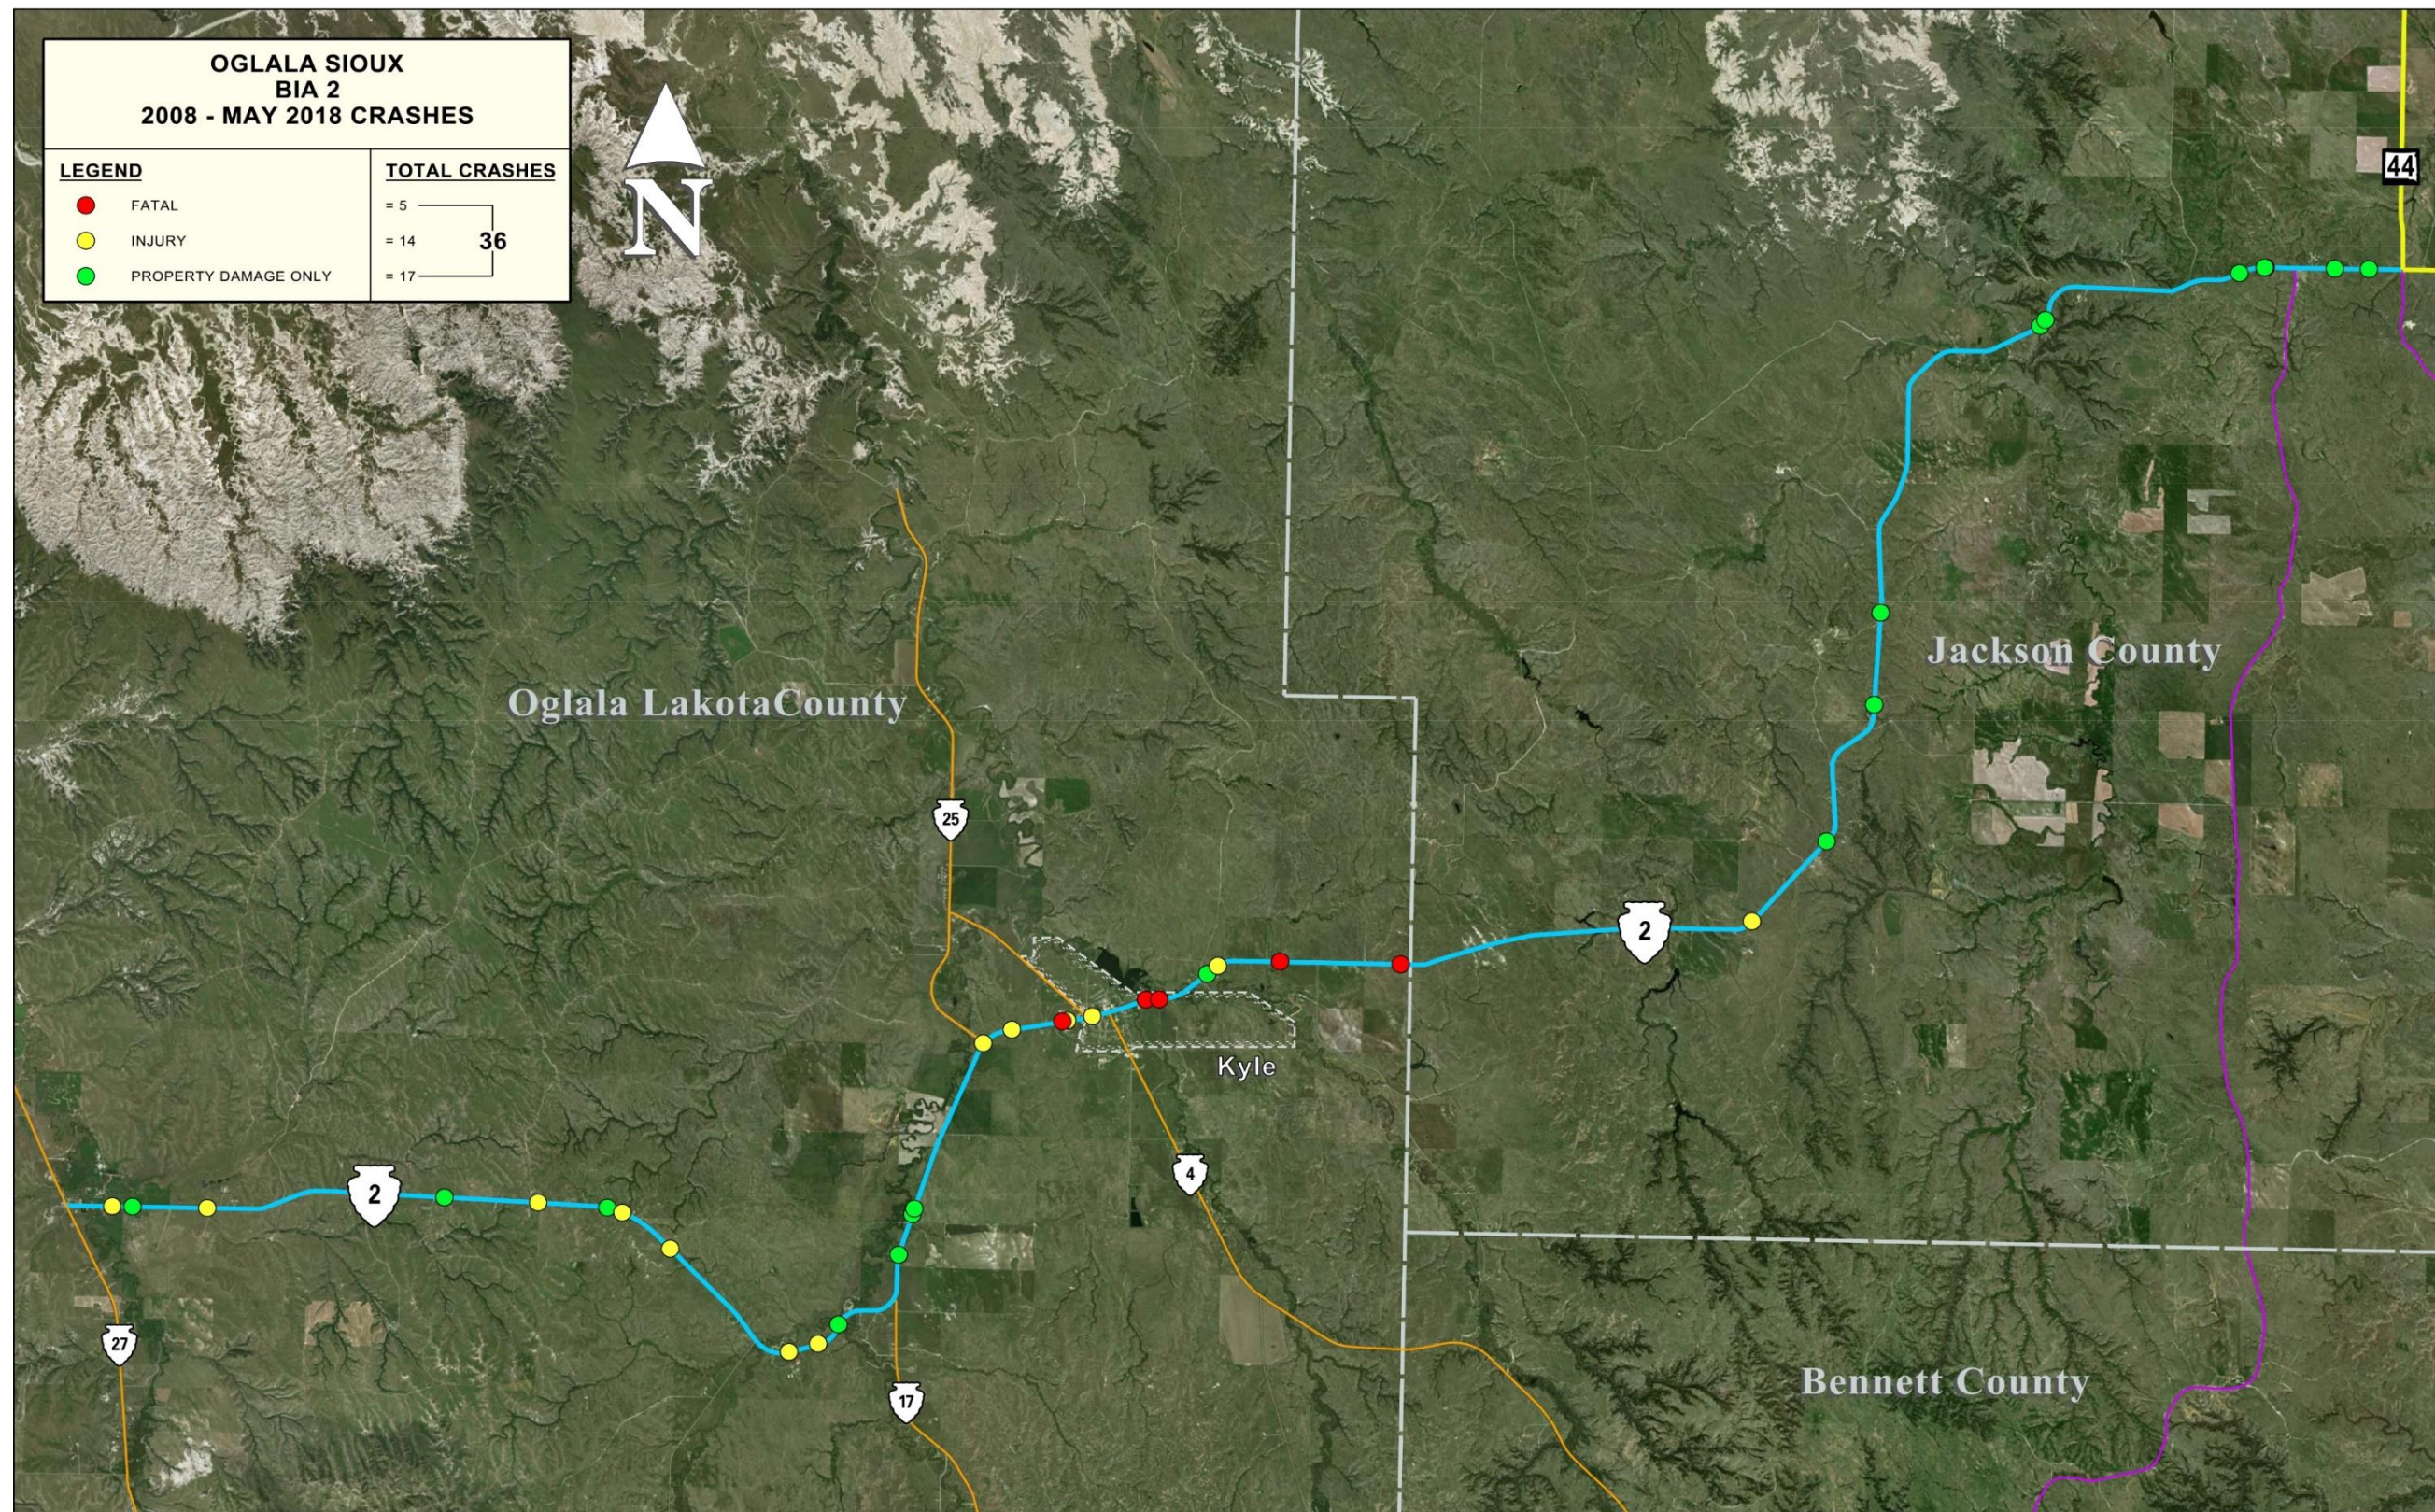
Figure 4.4: Crash Severity Location on BIA 2 (2008 – 2017)

**Key Observation:** Fatal and injury crashes stand out due to their impact on lives. A total of 19 of the 36 reported crashes or 53% resulted in fatal or injury crashes. Countermeasures discussed later in this report can help to greatly reduce crash types and severity. **Figure 4.3** shows the locations of the crash severity's that occurred on BIA 2.

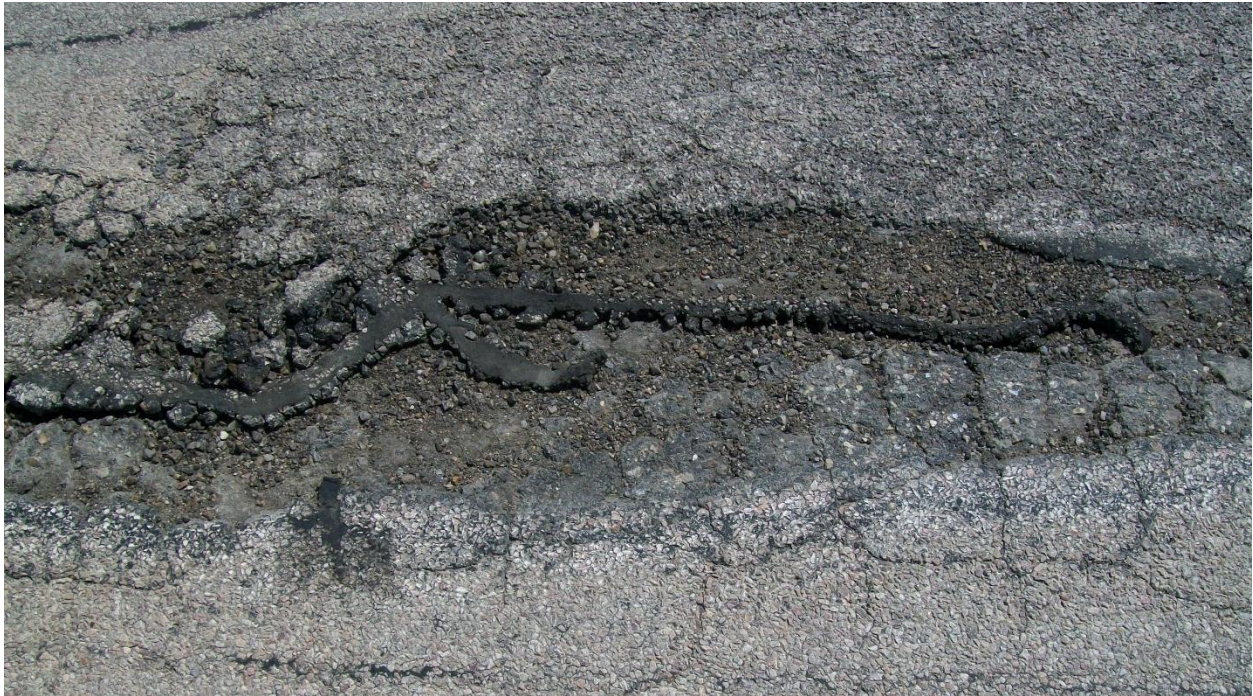
*Figure 4.5: Alligator Cracking on BIA 2*

BIA 2 is a paved route and an ideal driving surface; the conditions of the surface can influence the way motorists drive. The pavement on BIA 2 is showing signs of distress and is nearing the end of its design life for an asphalt roadway. BIA 2 is showing cracking, ruts, heaving and alligator cracking throughout the entire length of the corridor. Other contributing factors such as snow or ice on the roadway can contribute to crashes. Only four of the 36 crashes reported occurred when the road surface had ice/frost or snow/slush on it. One crash was reported as an unknown surface conditions and the remaining 31 crashes occurred on a dry surface.

**Key Observation:** Given that BIA 2 is nearing the design life for an asphalt roadway, a full reconstruct of the roadway should be considered. A milling and overlay typically seen to extend life of the road would build up from a thin asphalt lay and the edges would be tapered causing the road to be further narrowed.

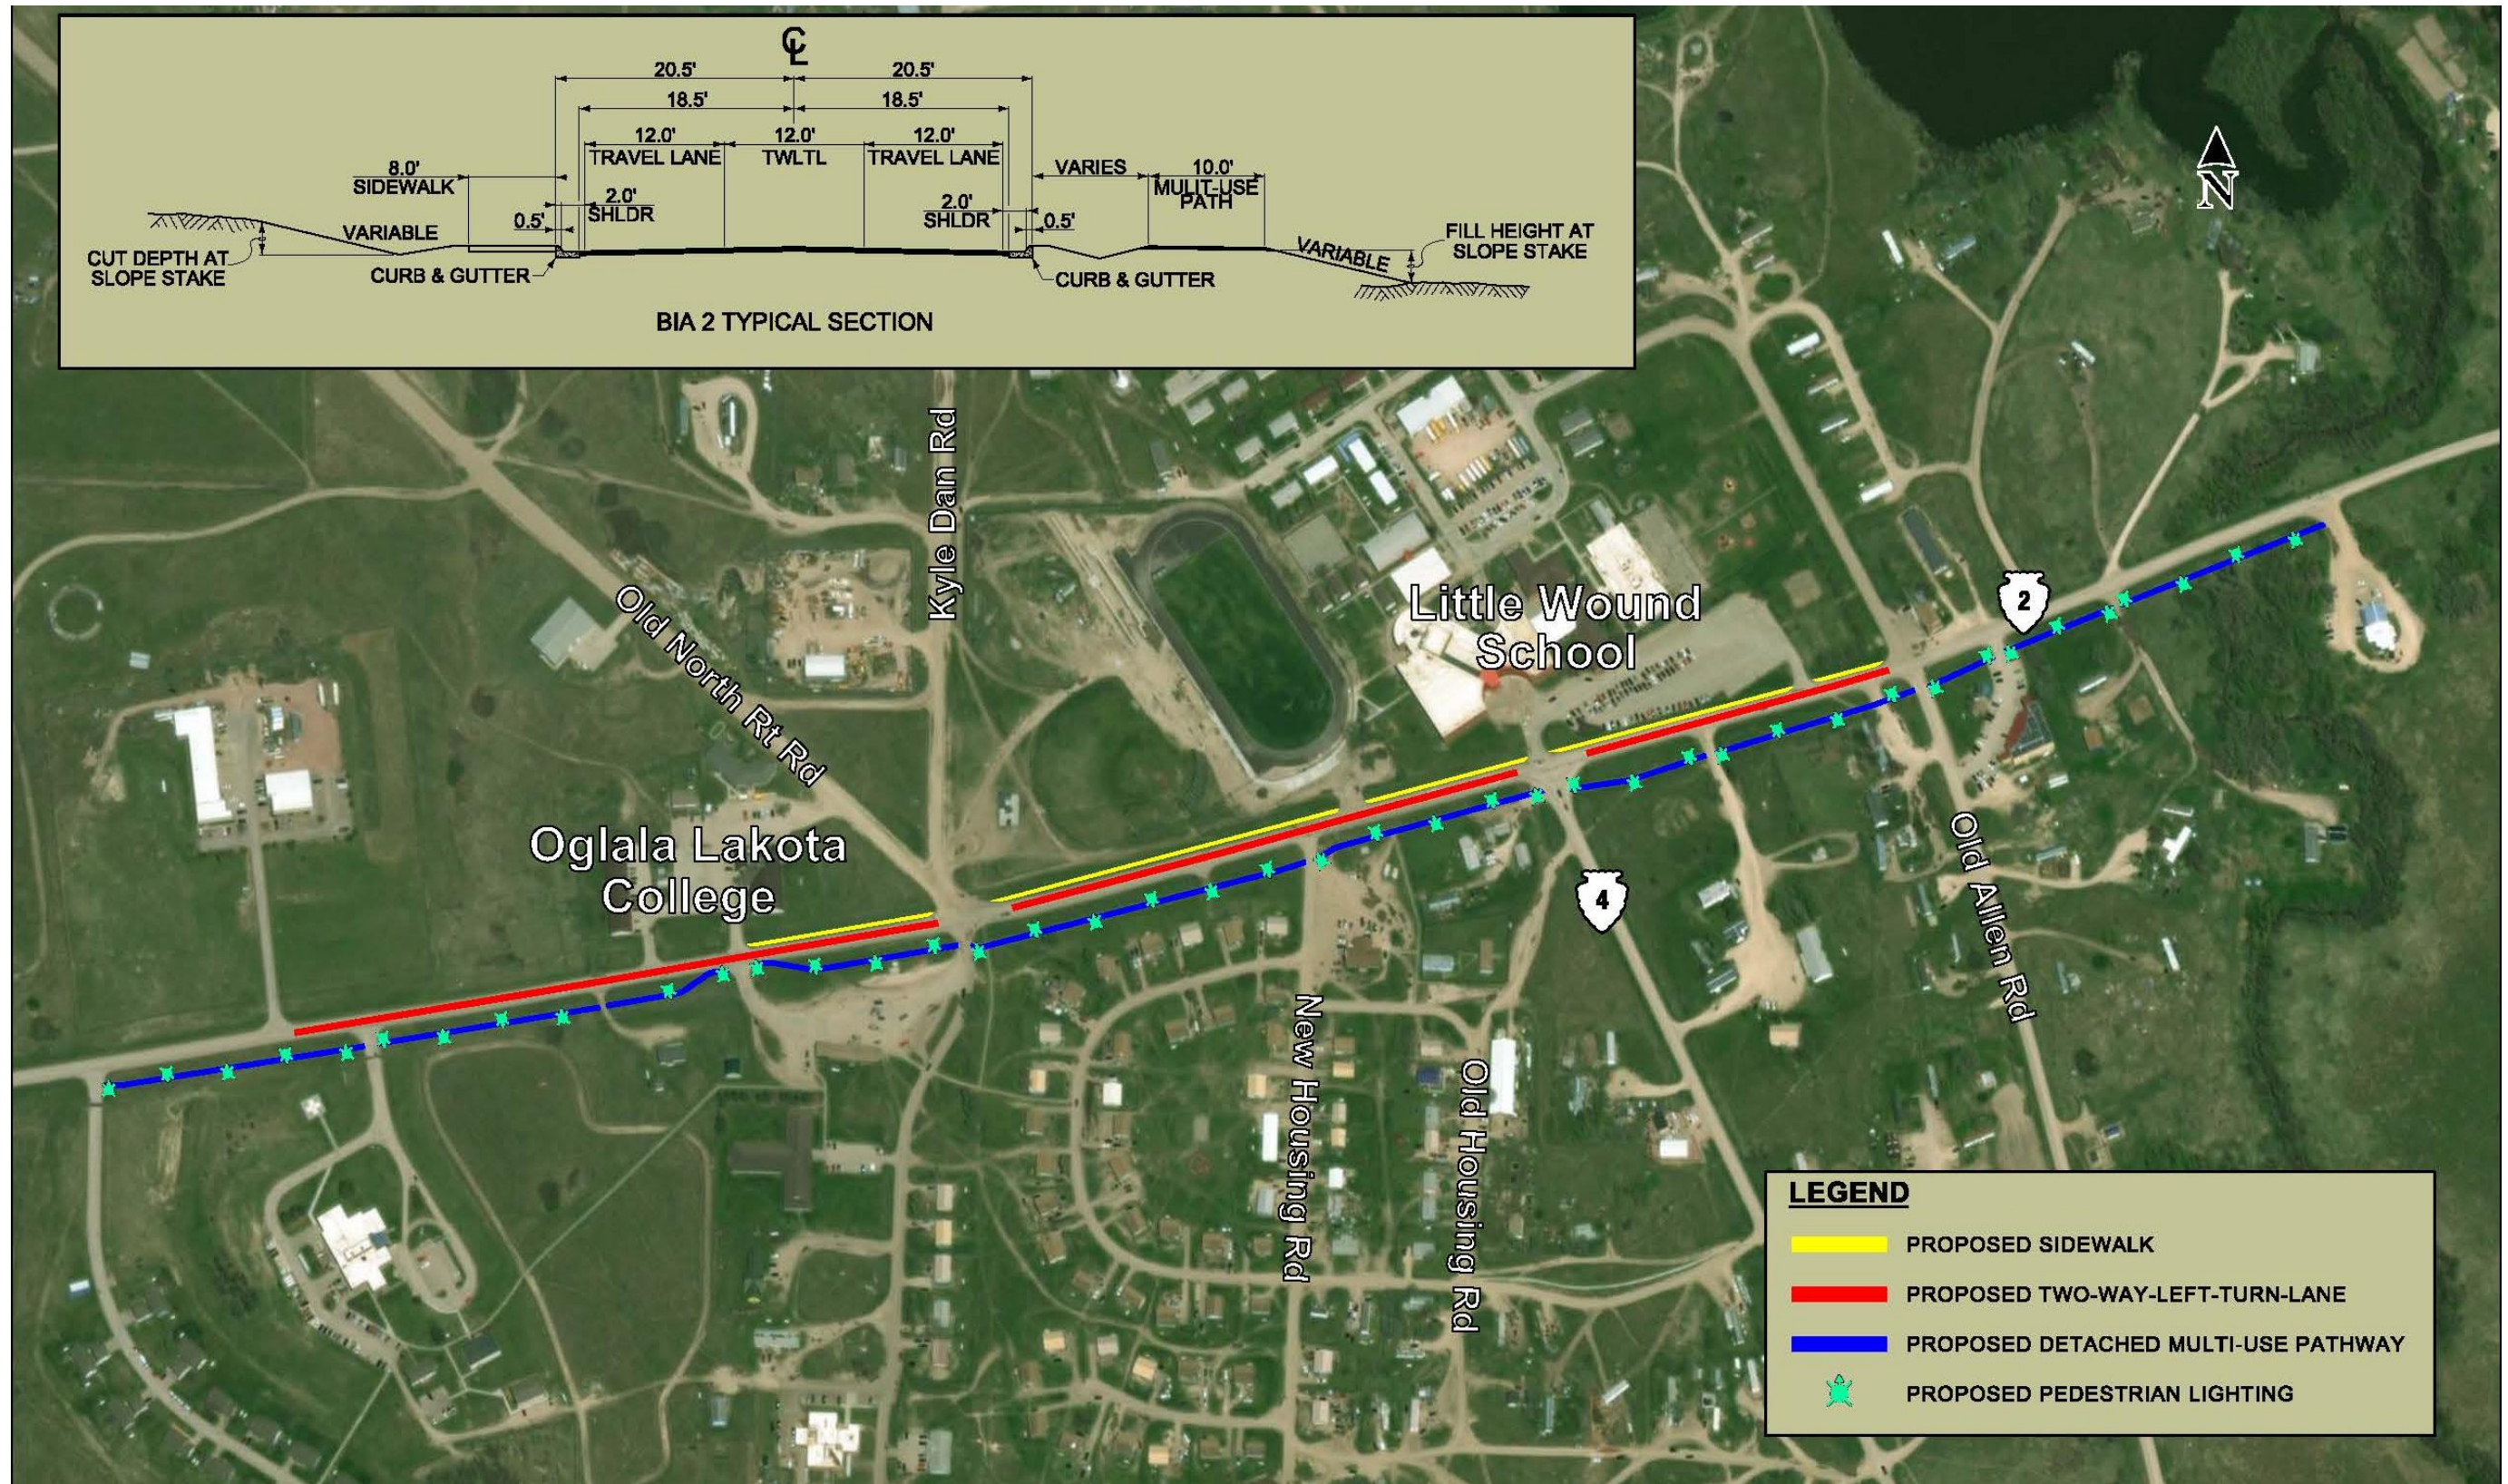
Figure 6.1 Overall Improvements in Kyle

With the high vehicle traffic in the area and the presence of two schools, grocery store, gas station, convenience store, health clinic, tribal housing and other traffic generators there is significant conflict between through vehicles, turning vehicles, vehicles accessing BIA 2 and pedestrians. The first recommendation was to alleviate the interaction between turning vehicles. It was determined that the best approach to doing this was to change the cross section of the roadway from a rural 2 lane road to an urban section with a two-way left turn lane, curb and gutter and sidewalks. This section is recommended from the health clinic on the west end of town up to the intersection with Old Allen Road as seen in **Figure 6.1**.

With the two schools, housing, commercial and health facilities that all generate considerable pedestrian traffic the need for improved pedestrian facilities clearly exist. As part of the overall improvements in Kyle it is recommended that a 10' wide separated shared use pathway be installed on the south side of the route from the Hospital Housing on the west end of town to the Grocery Store on the east end. With little to no roadway lighting in the area and to improve safety and security of those using the pathway, pedestrian lighting should also be installed along the pathway. The pathway is recommended on the south side of the road due to the relatively large amount of space that exists there and as not to impact college or school land and facilities. With both the College and the Little Wound School being located on the north side of BIA 2, within the urban section it is recommended that an 8' sidewalk be included to connect these facilities. These recommendations can also be seen in **Figure 6.1**.

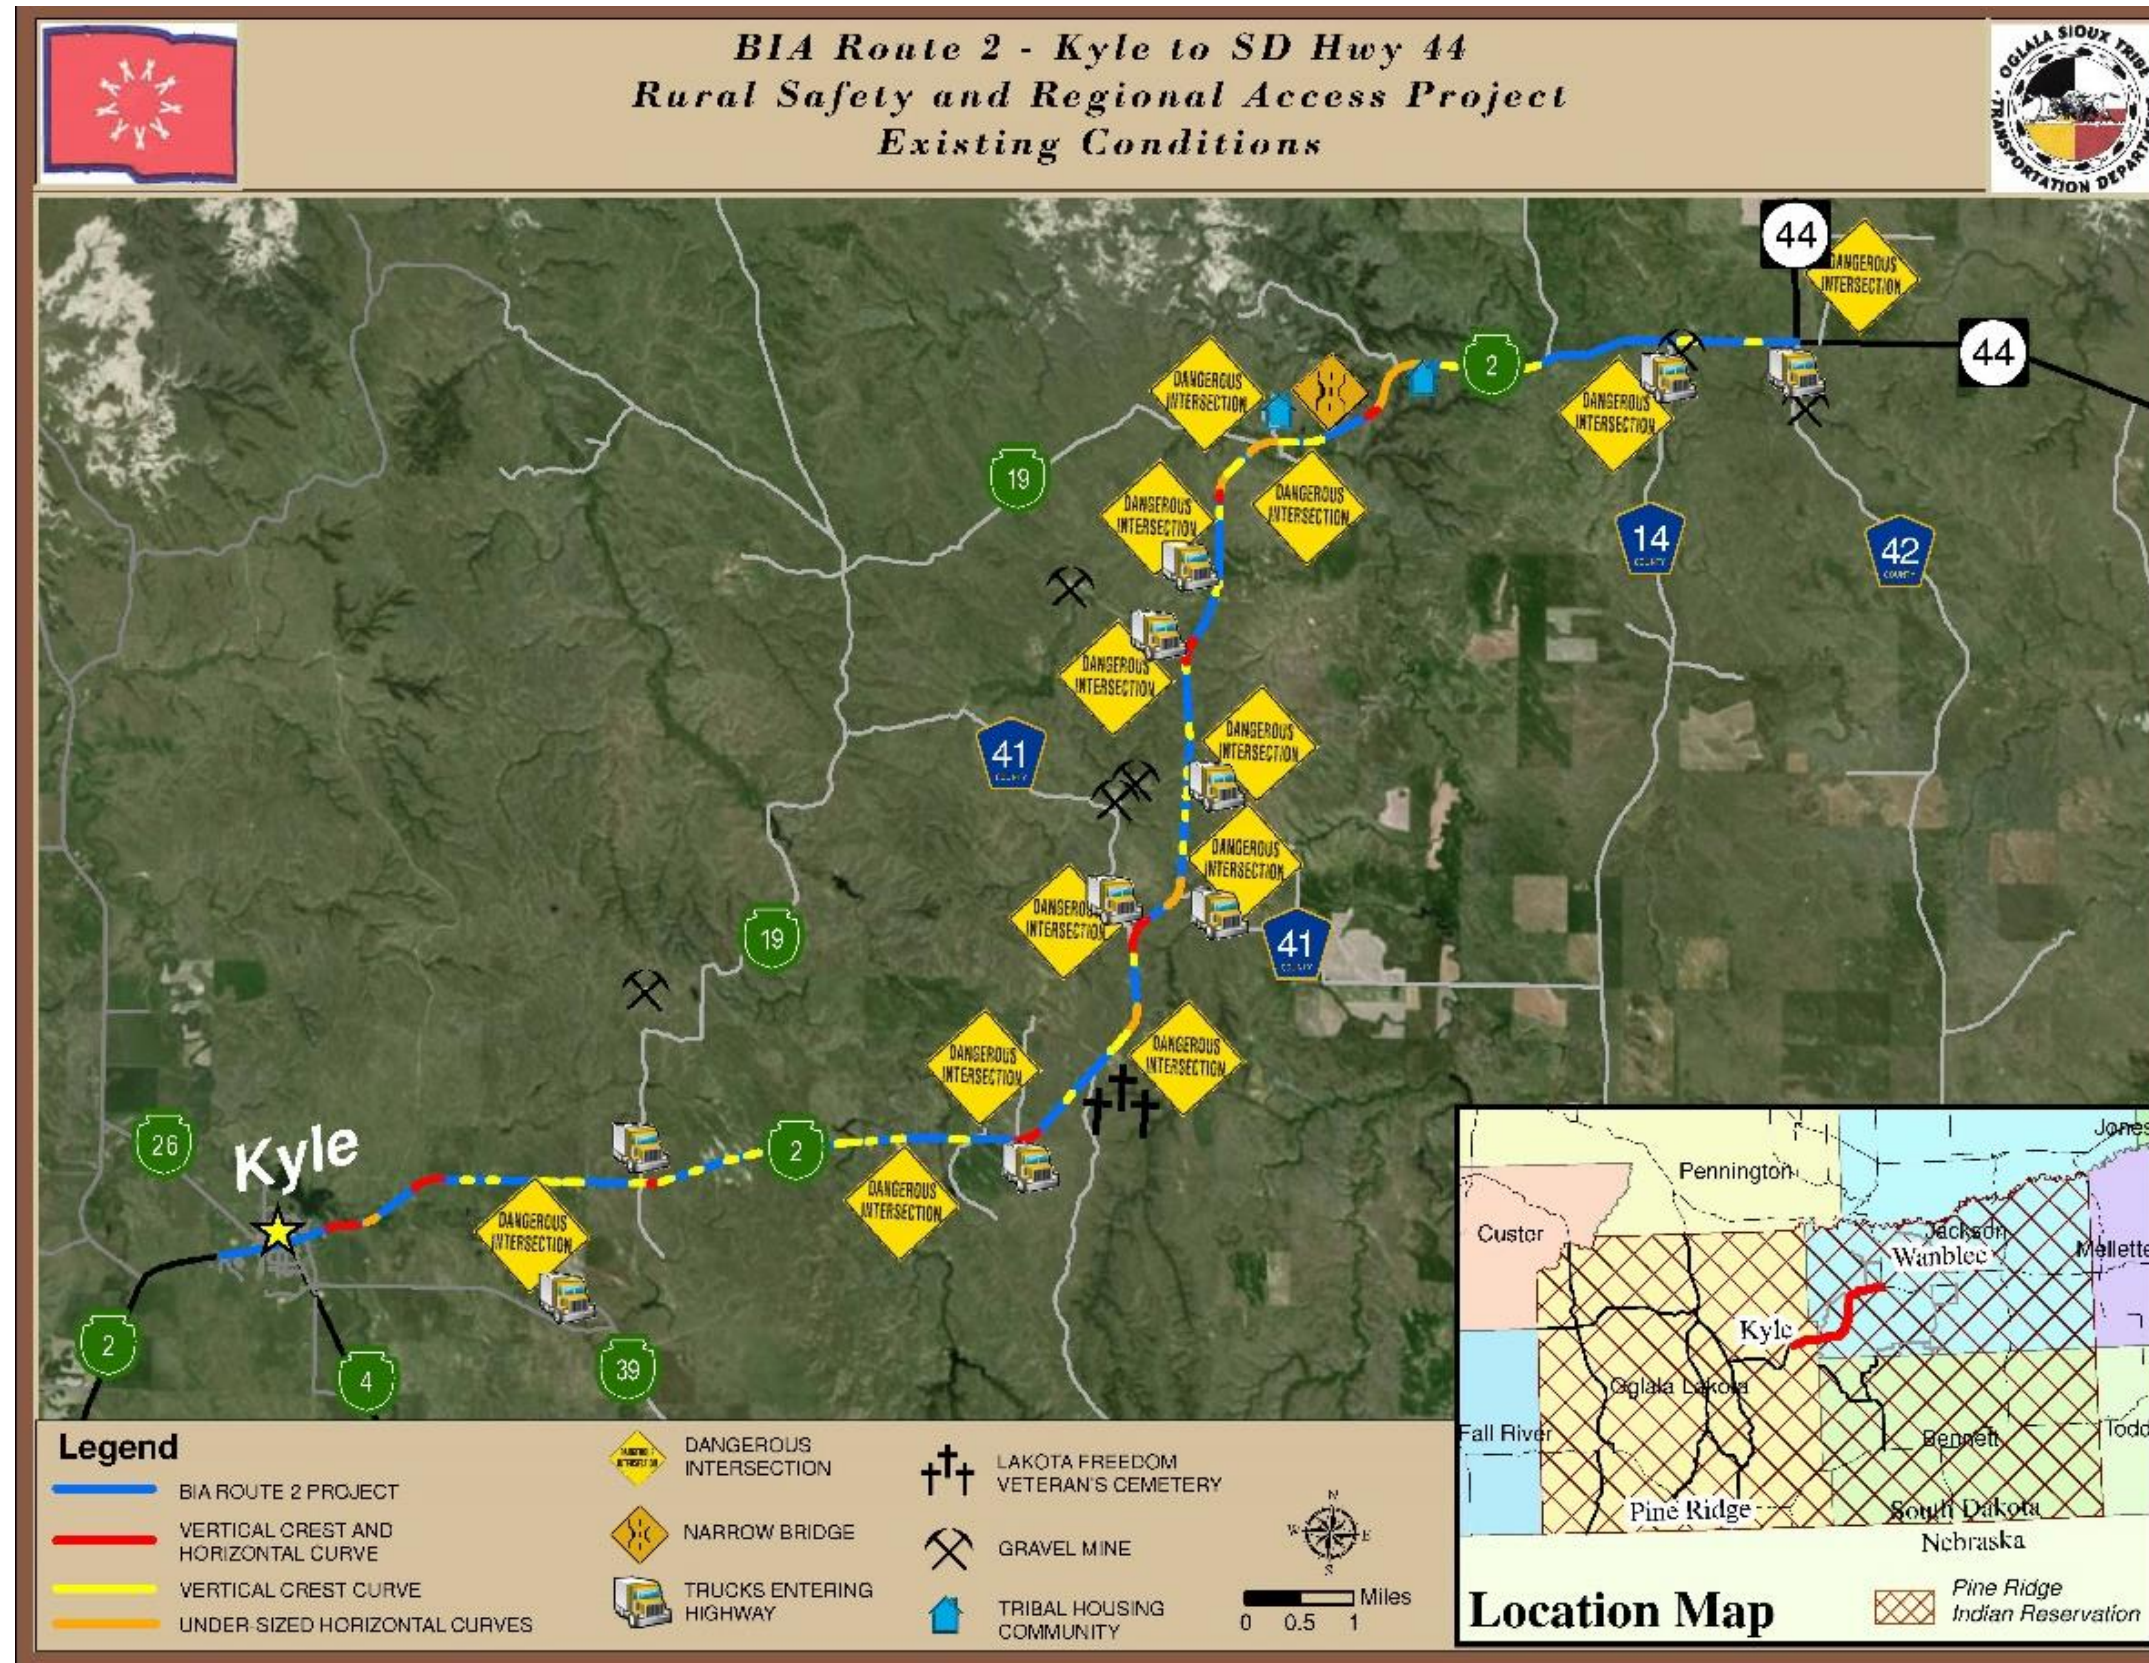
Figure 6.5 Rural Safety Conditions

To help to identify the scale of the alignment issues and how it affects intersection sight distance and other safety parameters, locations where vertical and/or horizontal curves were an issue were mapped out. Also included were intersection and locations where trucks could be entering the highway from gravel pits and other locations along the road. These are identified in **Figure 6.5**.

Initially, we looked to see what countermeasures could be installed at specific locations, however due to the narrowness of the roadway and poor condition of the pavement we determined that it was not feasible to install guardrail or rumble strips without widening of the road. Delineators, while they could be installed would be very close to vehicles and would be hit at a high rate and trying to maintain them would be a safety concern. As **Figure 6.5** showed, the nearly continuous alignment issues, as well as the continuous steep slopes and narrow width, makes addressing them a full reconstruction project.

While the signing for the route could be upgraded, it was felt that this in and of itself would be such a minor improvement and not address the significant safety concerns throughout the corridor. So, the RSA team recommends all of these items be included in a reconstruction of the entire rural section.
