# 2018 ROAD SAFETY AUDIT

Oglala Sioux Tribe

*July 2018*

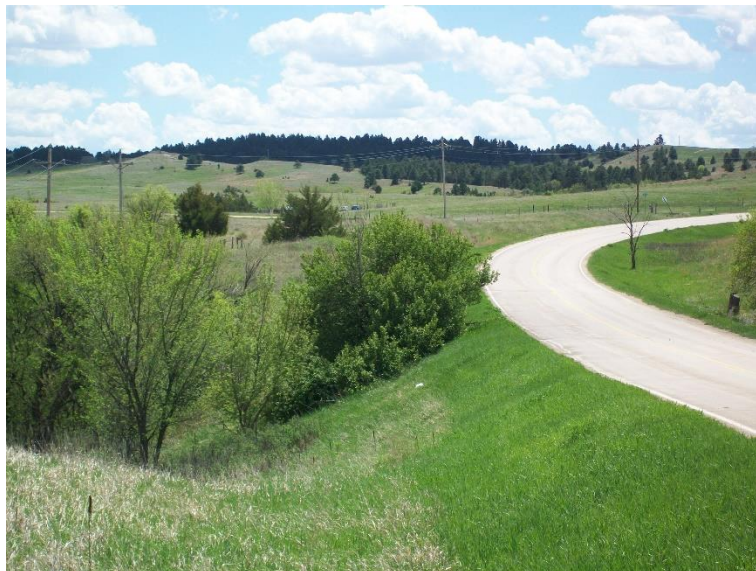
*Figure 5.10: Sharp Horizontal Curve*

Reconstructing and flattening of sharp curves like the one shown in **Figure 5.10**, can help to reduce the number of vehicles that errantly leave the road often leading to severe crashes. Guidance for curve radius and super elevation can be found in the American Association of State highway and Transportation Officials (AASHTO) A Policy on Geometric Design of Highways and Streets.

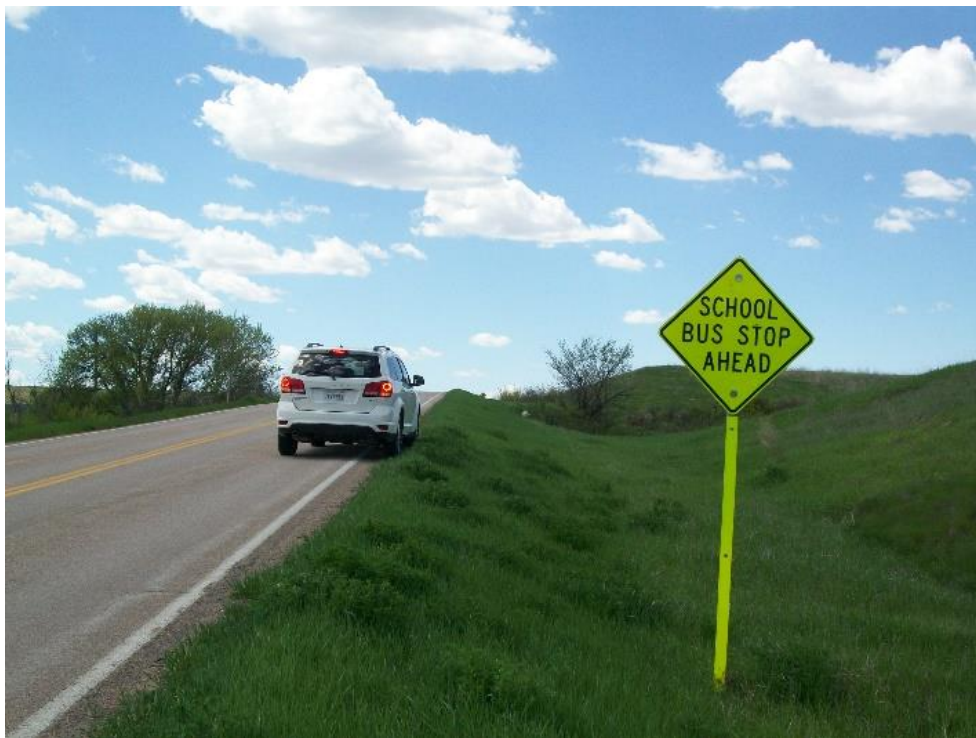
*Figure 5.11 Sharp Crest Vertical Curve*

Reconstructing and flattening sharp crest vertical curves that do not allow for adequate stopping sight distance have been shown to have significant positive impact on crashes. For rural two lane roadways like the location shown in **Figure 5.11**, injuries and fatalities have shown to be reduced by 50%.

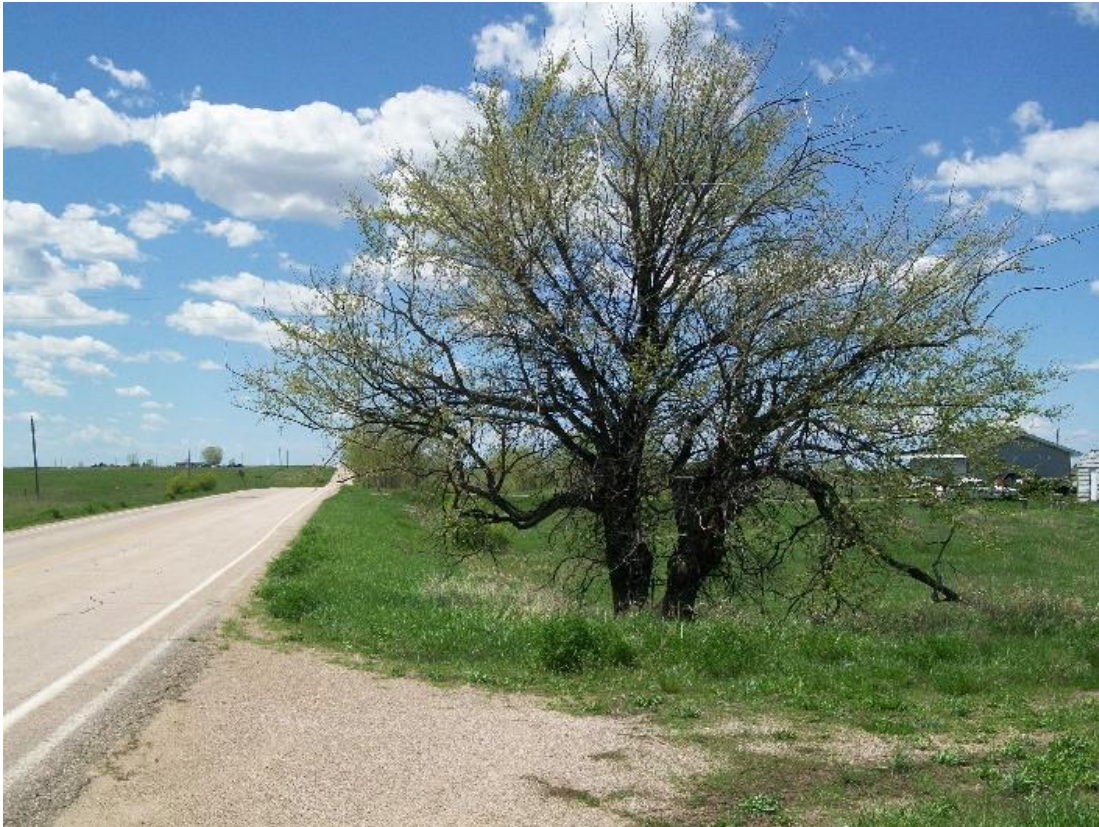
*Figure 5.12 Example Fixed Object*

Fixed objects such as tree, utility poles, mailboxes and rocks, such as shown in **Figure 5.12**, that are within the designated clear zone near the roadway have been found to be a significant cause of crashes, particularly injuries and fatalities in rural areas. Removal of these hazards can significantly reduce crashes and severity. Information on clear zone limits and calculation can be found in the AASHTO Roadside Design Guide.
